THE SECRETARY
OF THE INTERIOR'S
STANDARDS FOR
THE TREATMENT
OF HISTORIC
PROPERTIES

GUIDELINES FOR PRESERVING, REHABILITATING, RESTORING & RECONSTRUCTING HISTORIC BUILDINGS

# Revised by Anne E. Grimmer

> U.S. Department of the Interior National Park Service Technical Preservation Services Washington, D.C.

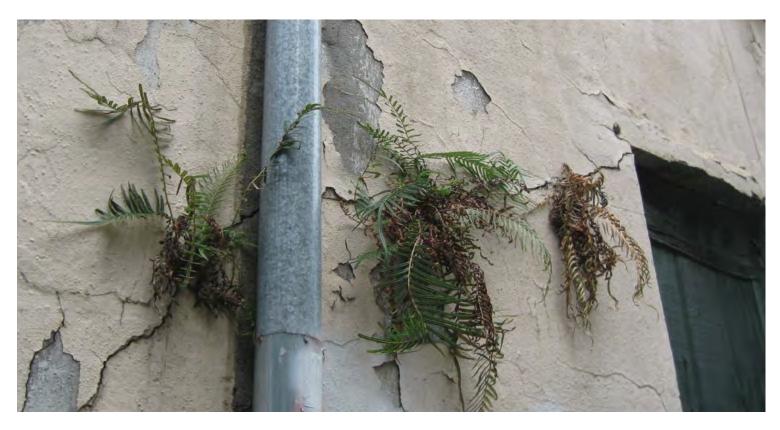
[3] **Not Recommended:** Cracks in the stucco have not been repaired, thereby allowing ferns to grow in the moist substrate which will cause further damage to the masonry.

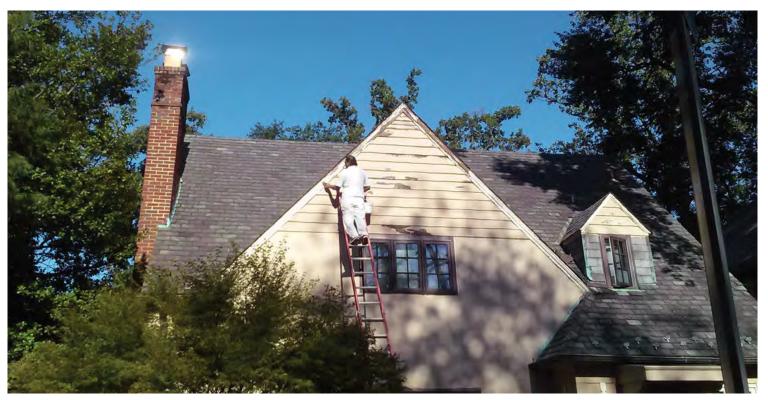
[4] Hand scraping to remove peeling paint from wood siding in preparation for repainting is an important part of regularly-scheduled maintenance.

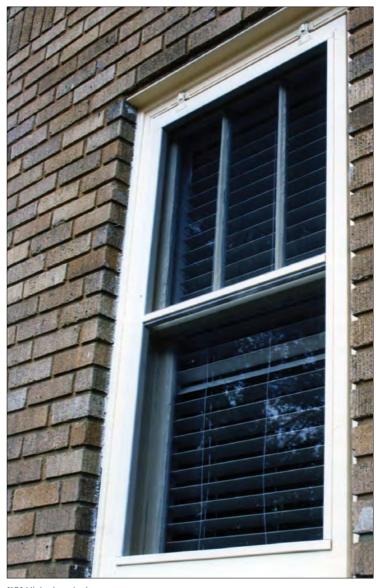
[10] Historic exterior storm windows preserve and help to insulate wood windows.

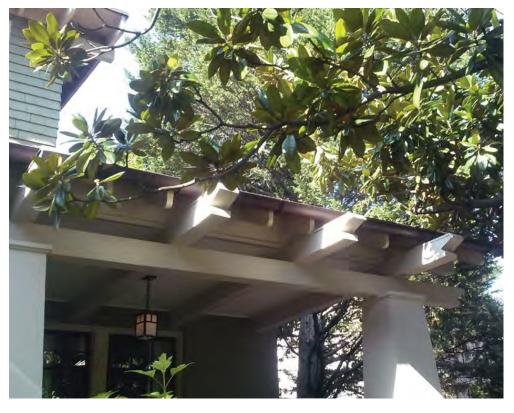
[12] Repair and limited replacement in kind to match deteriorated wood porch features is always a recommended preservation treatment.

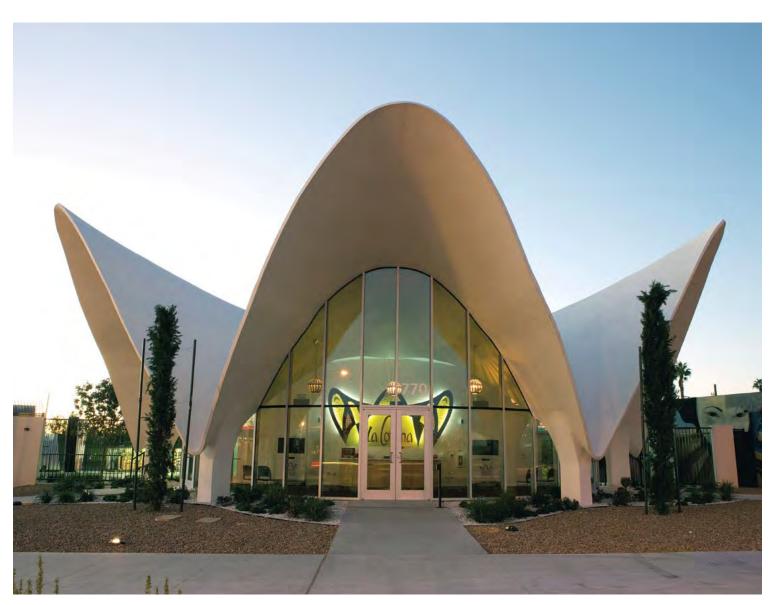
[2] Mid-century modern building technology made possible the form of this parabolashaped structure and its thin concrete shell construction. Built in 1961 as the lobby of the La Concha Motel in Las Vegas, it was designed by Paul Revere Williams, one of the first prominent African-American architects. It was moved to a new location and rehabilitated to serve as the Neon Museum, and is often cited as an example of Googie architecture. Credit: Photographed with permission at The Neon Museum, Las Vegas, Nevada.

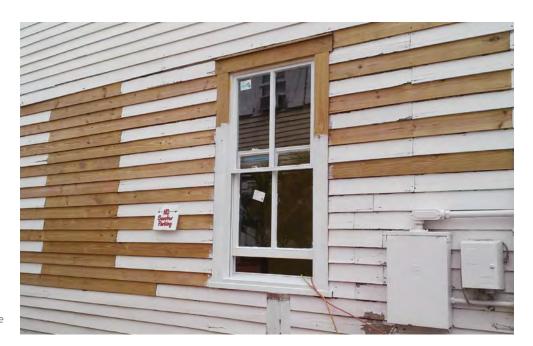
[8] Rotted clapboards have been replaced selectively with new wood siding to match the originals.

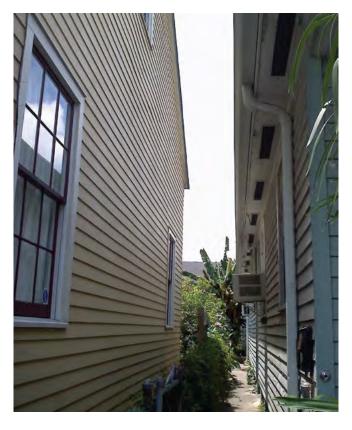
[9] Smooth-surfaced cementitious siding (left) may be used to replace deteriorated wood siding only on secondary elevations that have minimal visibility.

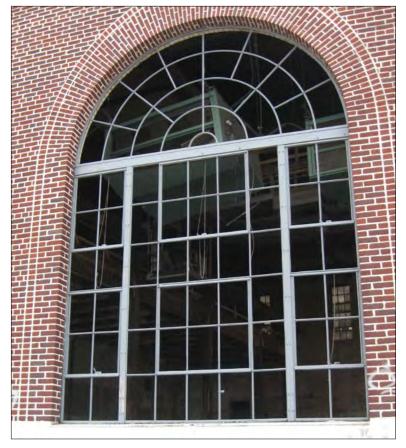
[12] This historic steel window has been cleaned, repaired, and primed in preparation for painting and reglazing.

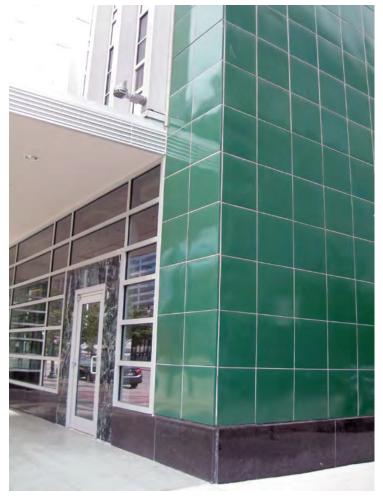
[15] New enameled-metal panels were replicated to replace the original panels, which were too deteriorated to repair, when the storefront of this early 1950s building was recreated.

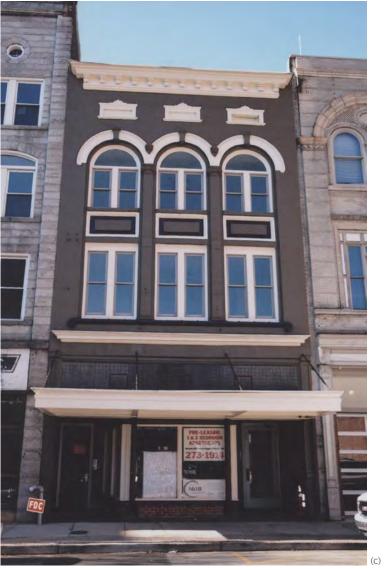
[22] **Not Recommended:** (a-b) The original wood windows in this late-19<sup>th</sup>-century building, which were highly decorative, could likely have been repaired and retained. (c) Instead, they were replaced with new windows that do not match the detailing of the historic windows and, therefore, do not meet the Standards (above).

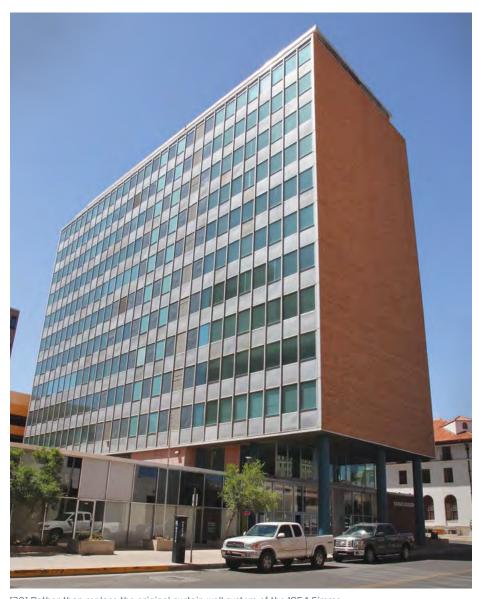
[30] Rather than replace the original curtain wall system of the 1954 Simms Building in Albuquerque, NM, with a different color tinted glass or coat it with a non-historic reflective film, the HVAC system was updated to improve energy efficiency. *Photo: Harvey M. Kaplan.*

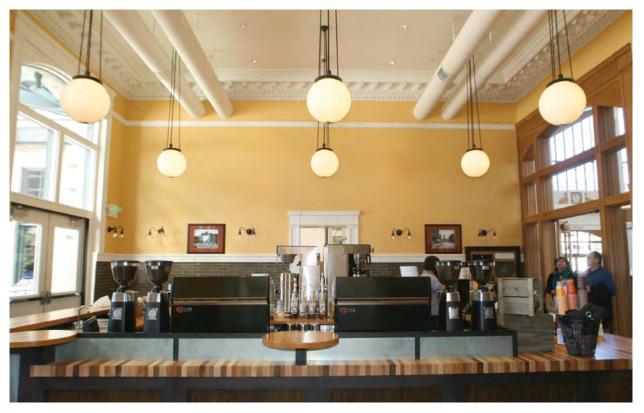
[37] Exposed and painted ducts were appropriately installed here in a retail space in Denver's historic Union Station after considering other options that would have impacted the ceiling height, or damaged or obscured the ornamental plaster crown molding. Photo: Heritage Consulting Group.

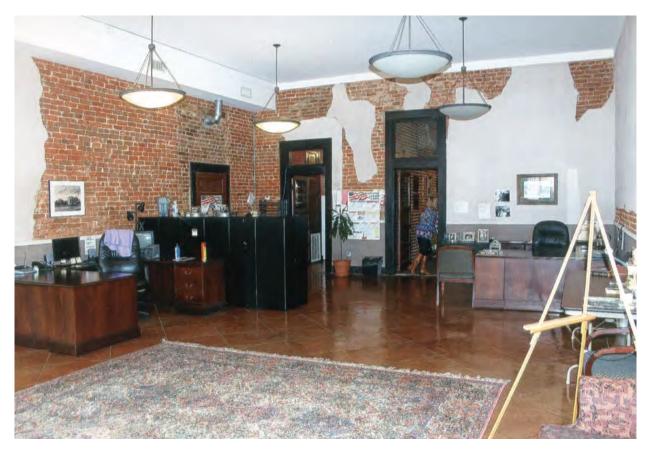
[41] Not Recommended: Leaving fragments of deteriorated or "sculpted" plaster is not a compatible treatment for either finished or unfinished interior spaces.

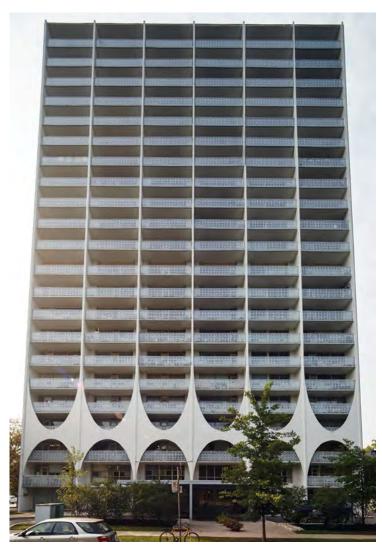
[59] (a-b) The decorative concrete balcony railings on this 1960s building did not meet life-safety code requirements. They were replaced with new glass railings with a fritted glass pattern matching the original design—a creative solution that satisfies codes, while preserving the historic appearance of the building when viewed from the street (c-d). Photos: (a, b, d) ERA Architects, Inc.; (c) Nathan Cyprys, photographer.

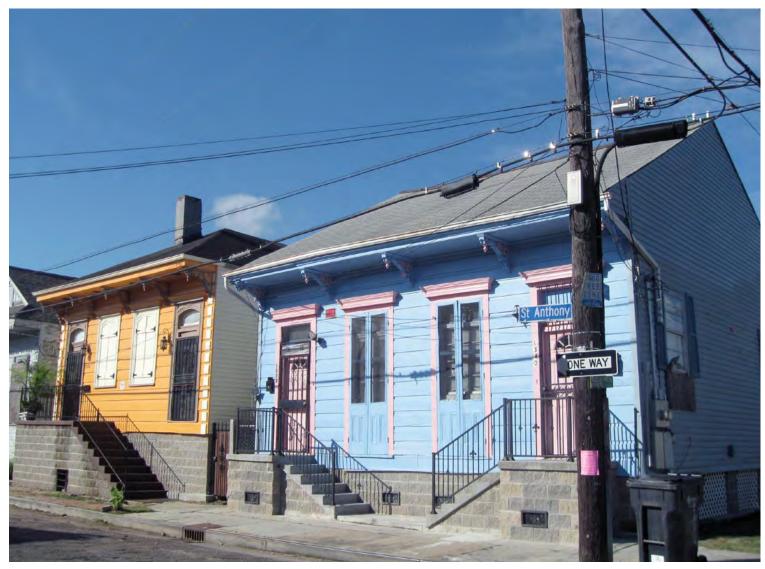
[60] In some instances, it may be necessary to elevate a historic building located in a floodplain to protect it. But this treatment is appropriate only if elevating the building will retain its historic character, including its relationship to the site, and its new height will be compatible with surrounding buildings if in a historic district. The house on the right, which has been raised only slightly, has retained its historic character. The house on the left has been raised several feet higher, resulting in a greater impact on the historic character of the house and the district.

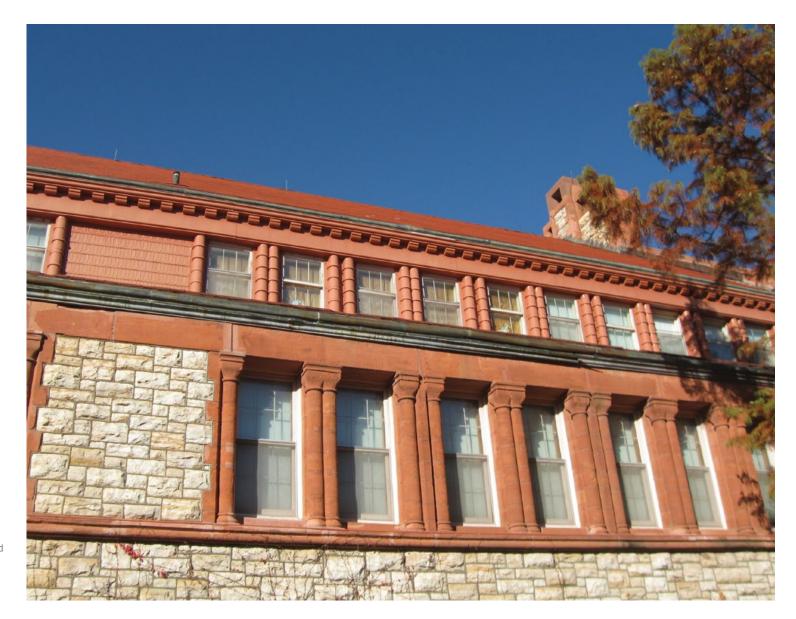
[6] Preliminary work before starting restoration revealed that the columns and the decorative shingles ornamenting the top floor of this historic building were fabricated of metal to imitate the red sandstone used elsewhere on the building.

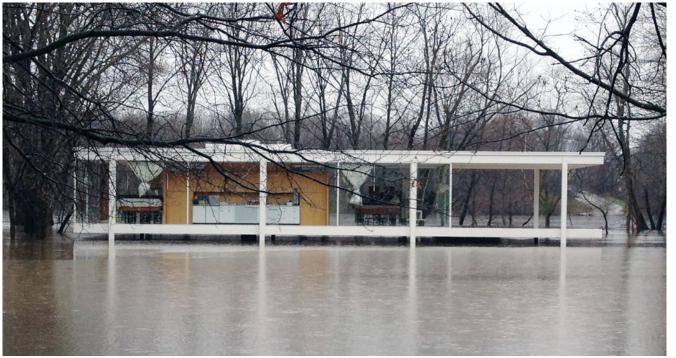
[19] The 1951 Mies van der Rohe-designed Farnsworth House, Plano, IL, was built close to the Fox River, which is increasingly prone to floods. To preserve the house in its original location, historic preservation architects and engineers continue to explore ways to protect it from the flooding, including a possible system that would lift the house above the flood waters and lower it back to the ground. Photo: Courtesy Farnsworth, A Site of the National Trust for Historic Preservation.

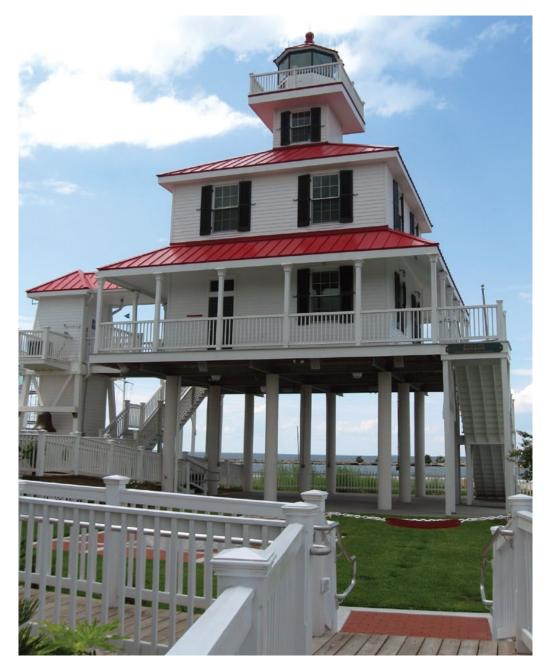
[6] This lighthouse on Lake Ponchartrain in New Orleans was reconstructed after the historic 1890 lighthouse was destroyed by Hurricane Katrina.
