# Limited Phase II Subsurface Investigation Report

987 Main Street  
Minturn, Eagle County, Colorado 81645

AEI Project No. 468525

AEI Consultants  
2420 W 26<sup>th</sup> Avenue  
Denver, Colorado 80211  
Contact: Chris Viola, [cviola@aeiconsultants.com](mailto:cviola@aeiconsultants.com)  
303-916-1270

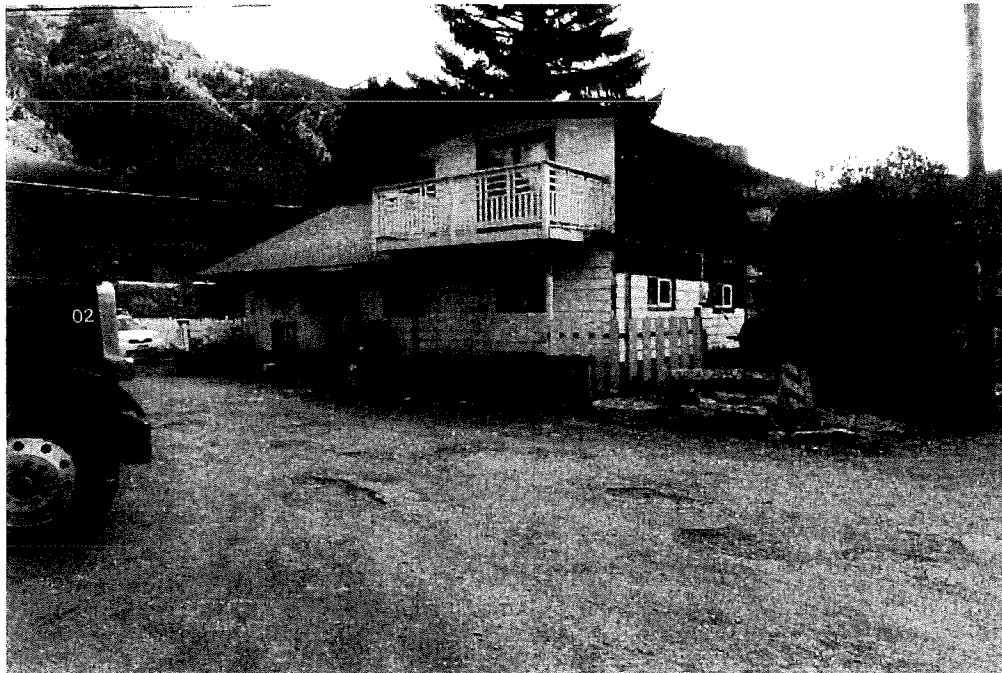
Photo 3 View to East of Residence, and Entrance Driveway – Gravel Surfaced Road

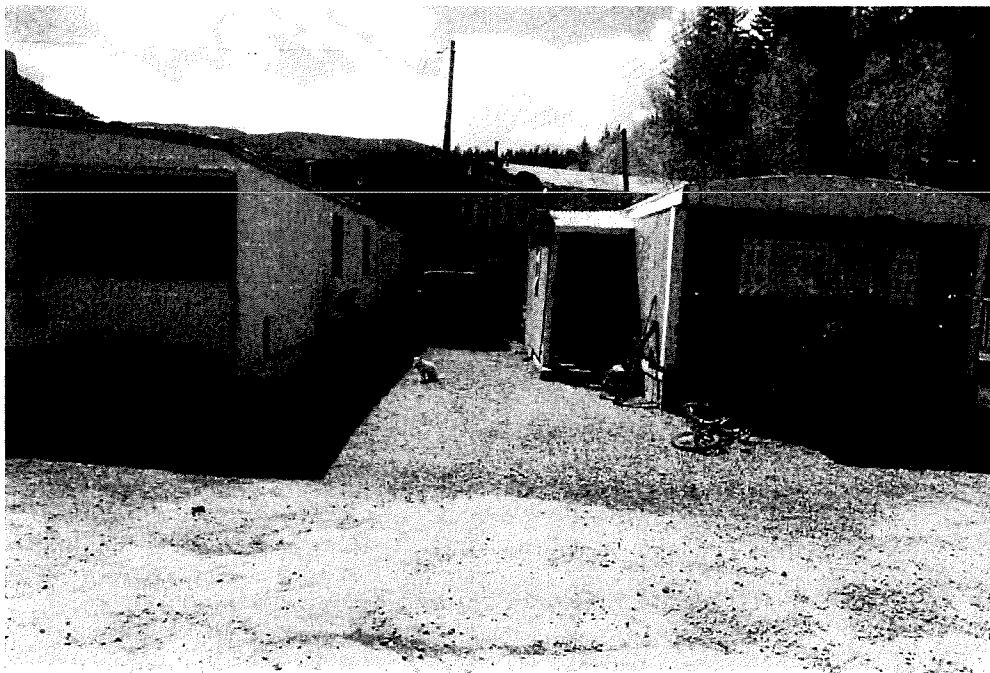
Photo 4 View to South of Typical Mobil Homes on Site – Steep Hillside is Visible in Upper Right of Photo  
– Building that once Housed Alpine Glass is Visible at Center Top

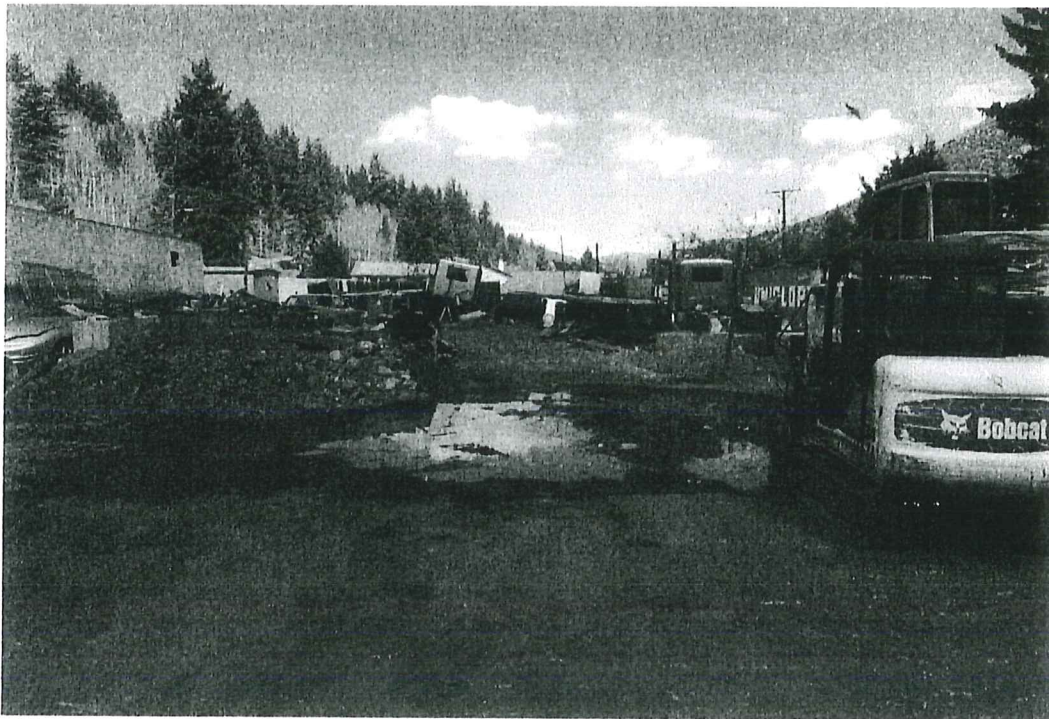
The inspection found no evidence of any odors or sheen on the water, thus no negative environmental conditions were found associated with the grate.

Photo 6 View North of Working Part of Storage Area with Water in Low Area from Recent Rains – Note Water is Clean and Shows no Evidence of any Contaminants or Sheen- A Small Above Ground Fuel Storage Tank Had Been at this Location For a Short Time a Few Years Ago

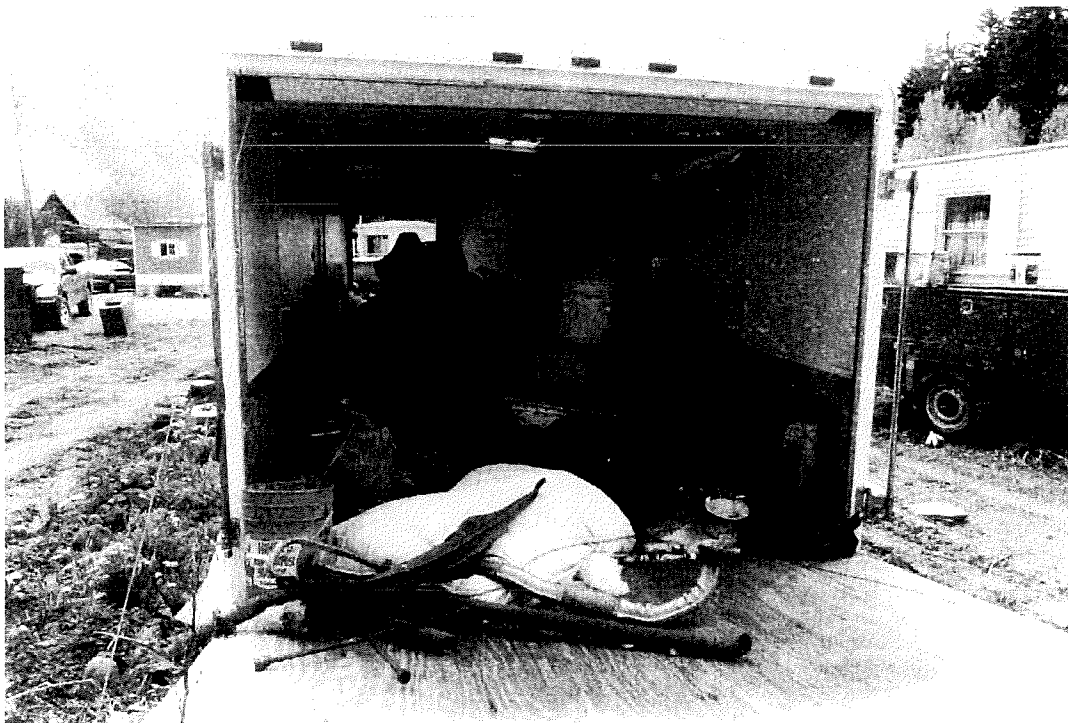
Photo 7 Inside of Storage Trailer- Unorganized

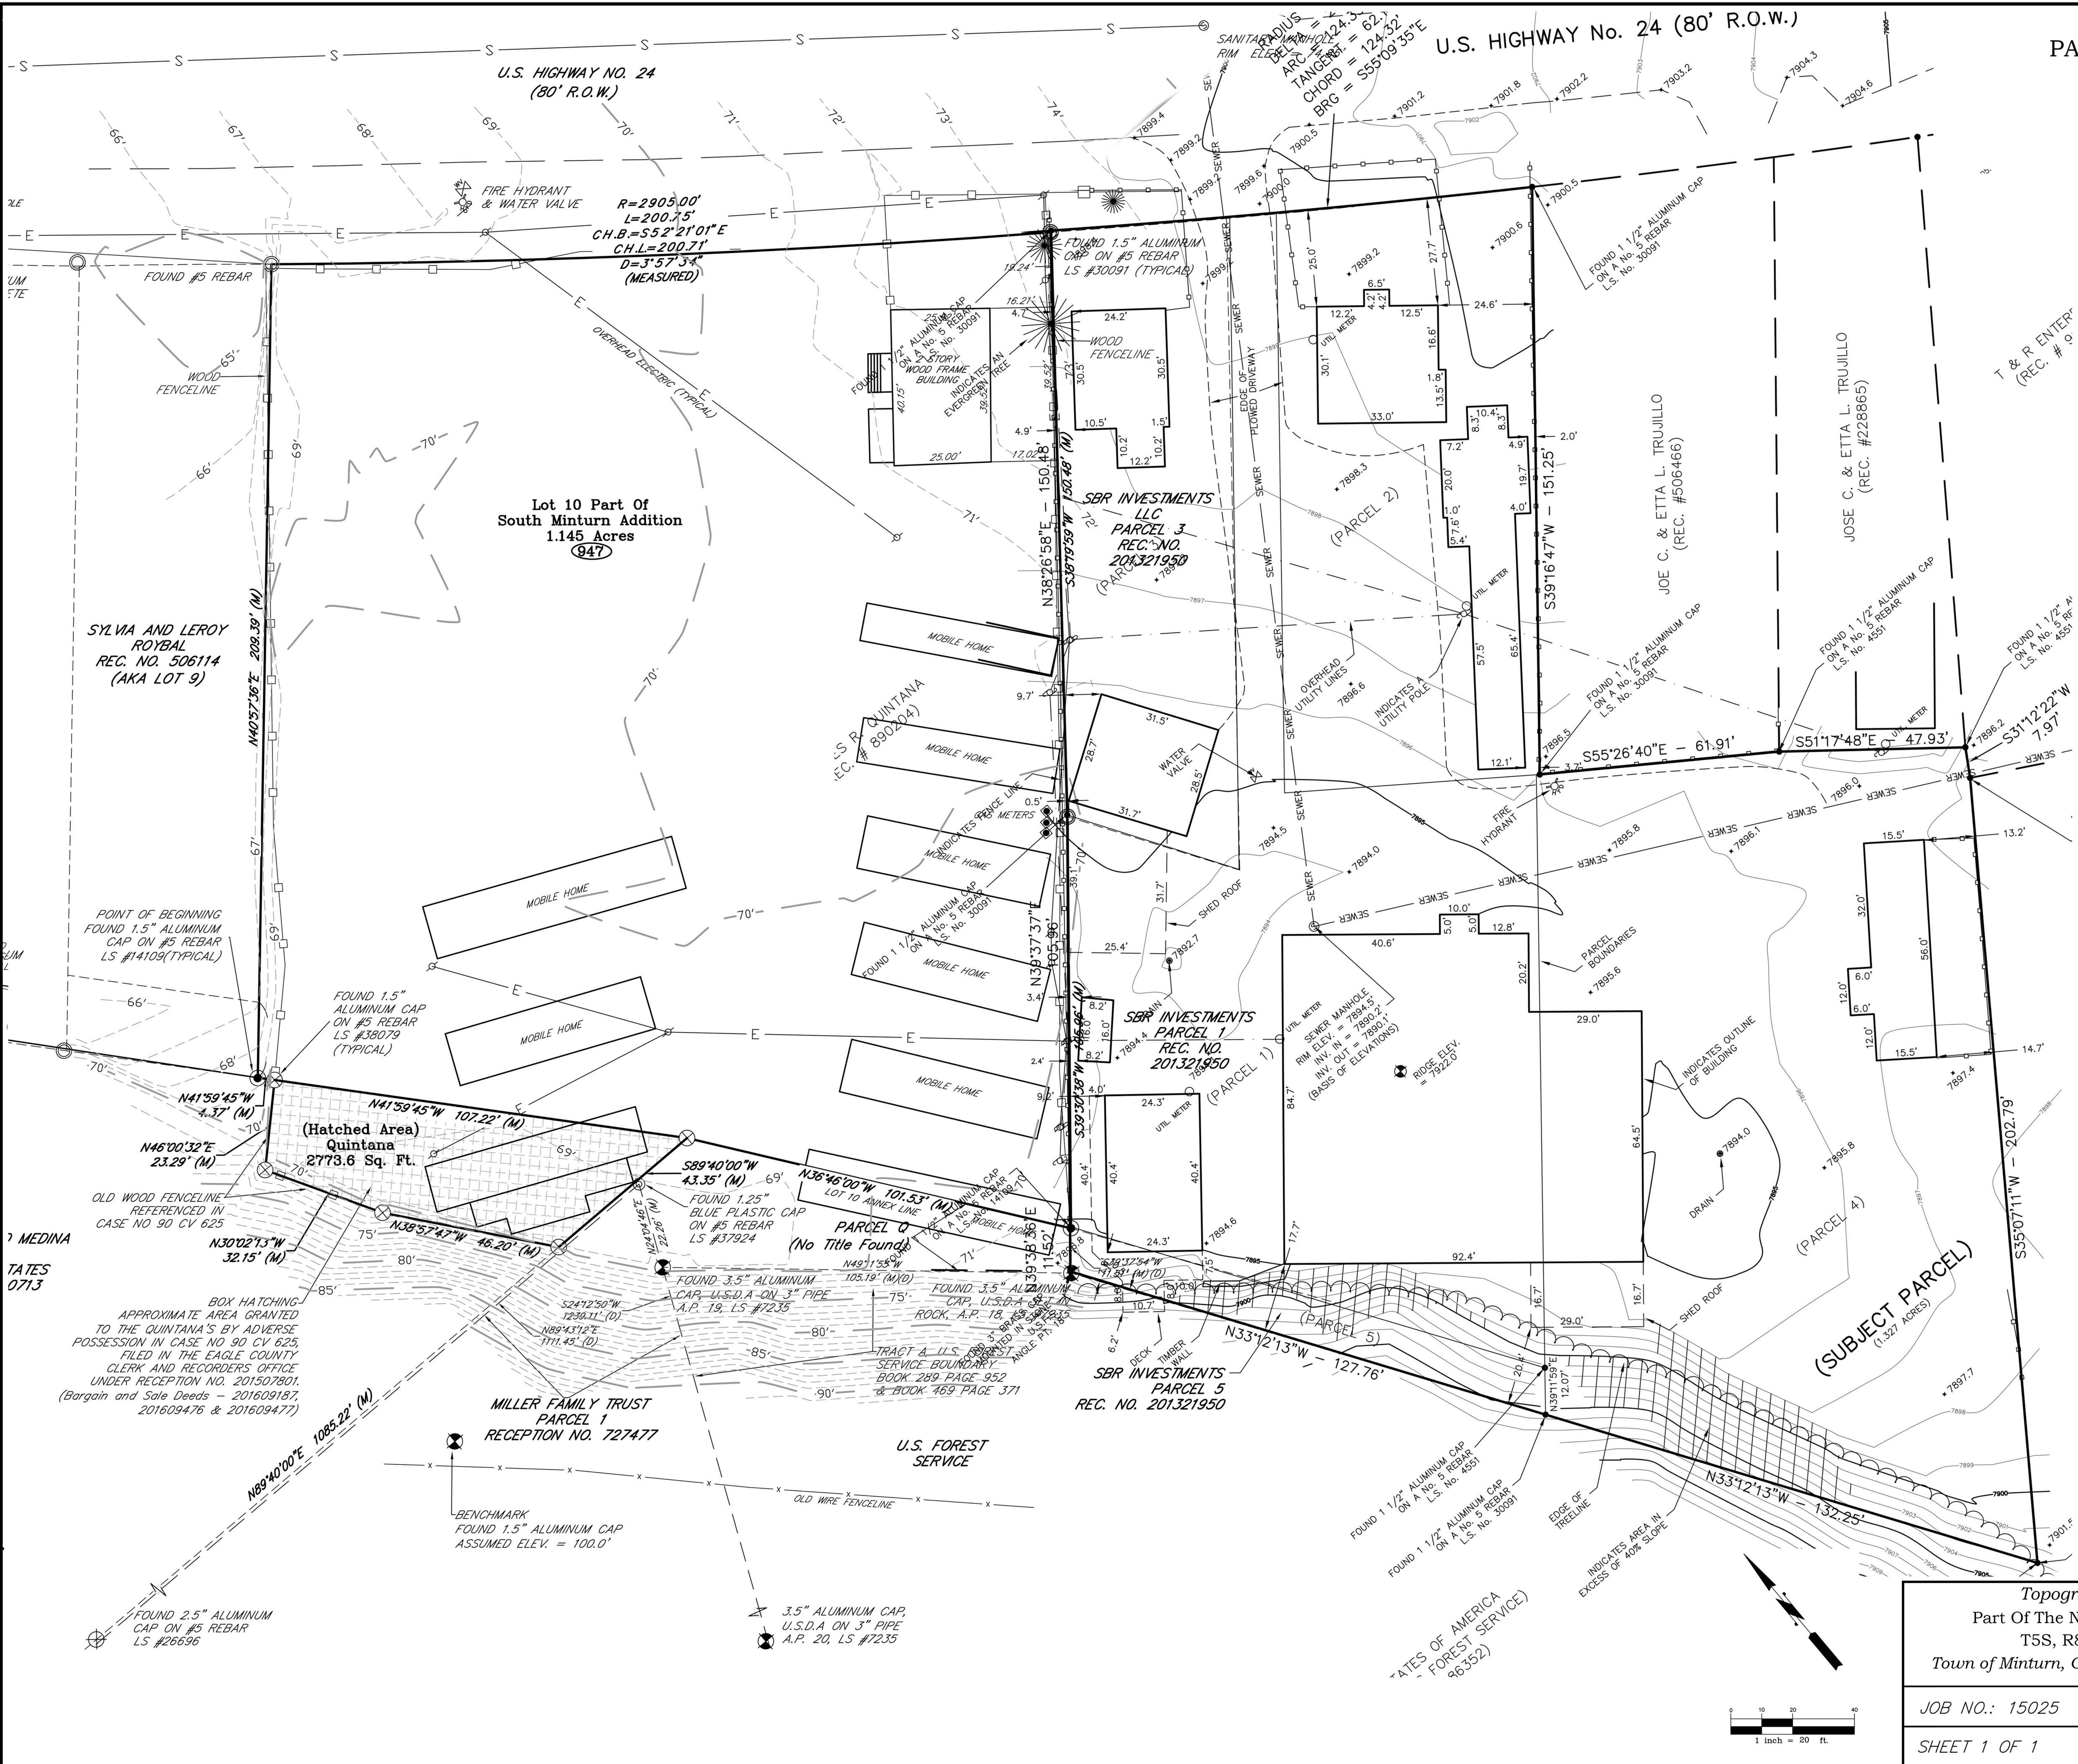
At the request of the client, Land Title Guarantee Company did a title search on the subject property and results are summarized in Appendix B. A survey map was provided to Braun by the client, prepared by Kipp Land Surveying Company of Englewood, Colorado as Figure 3 (Appendix A). The map shows the permanent buildings and mobile home units with respect to their location to property boundaries. As other items stored on the site are not considered permanent, they are not shown on that map.

The Subject Property is known as Quintana Property and is located at 947 Main Street in Minturn, Colorado (Figure 2, Appendix A), totaling 1.082 acres. The property is at an elevation of approximately 7,900 feet above mean sea level. The parcel is roughly square with the dimensions in both the north-south and east-west directions being a little over 200 feet. More specifically, the subject property described as part of the northeast quarter of Section 35, Township 5 South Range 81 West of the New Mexico Principle Meridian, also known Lot 10, part of the South Minturn Addition. The boundary description can be found on the survey map, included as Figure 3, Appendix A in reduced size format.
