**Historic Preservation Commission (HPC) Agenda
Tuesday March 21, 2023 5:30 PM
Minturn Town Hall / 302 Pine St Minturn, CO**

The purpose of *The Secretary of the Interior's Standards for the Treatment of Historic Properties and Guidelines for Preserving, Rehabilitating, Restoring and Reconstructing Historic Buildings* is to provide guidance to historic building owners and building managers, preservation consultants, architects, contractors, and project reviewers prior to beginning work. It is always recommended that preservation professionals be consulted early in any project.

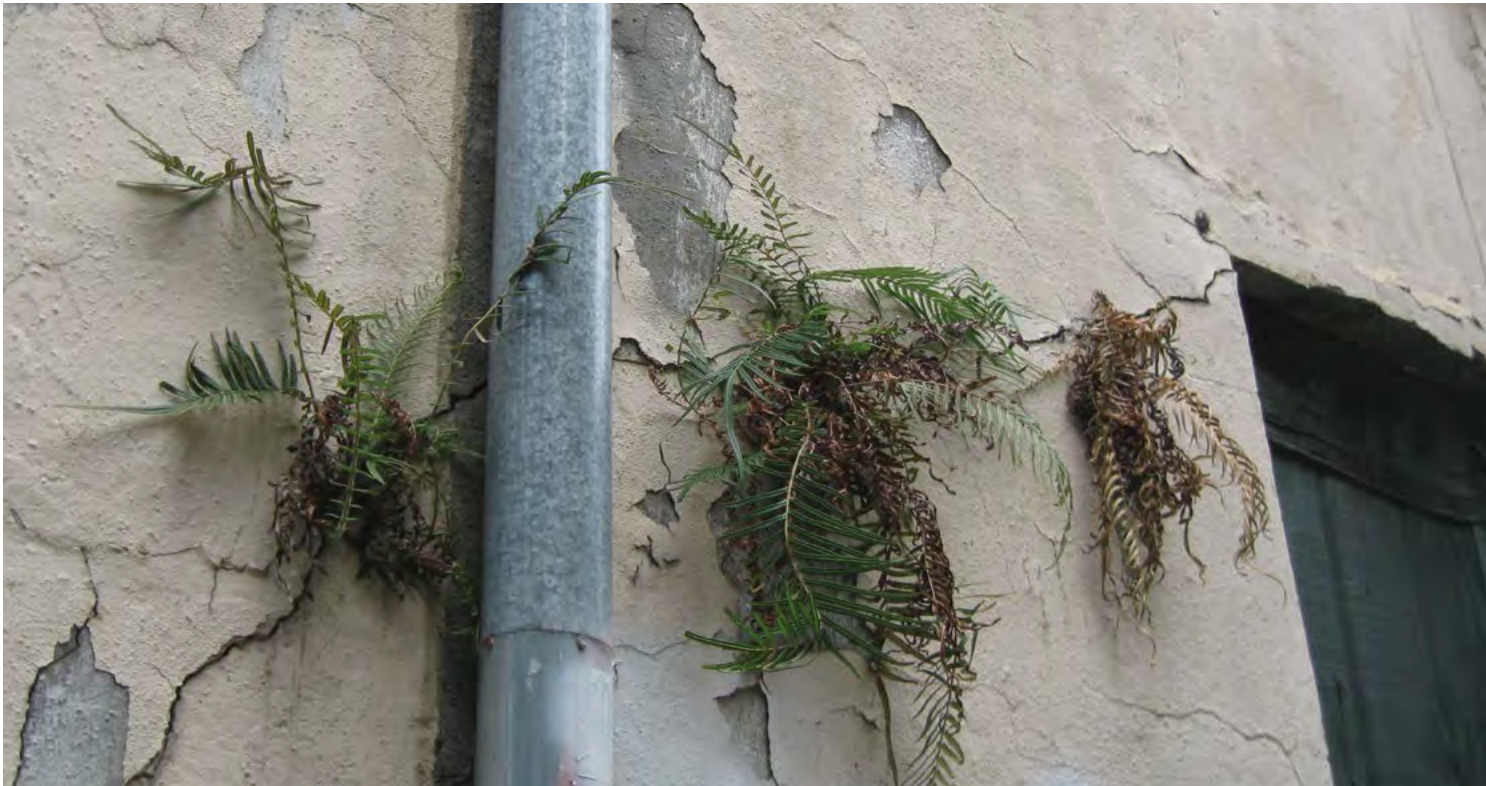
[3] **Not Recommended:** Cracks in the stucco have not been repaired, thereby allowing ferns to grow in the moist substrate which will cause further damage to the masonry.

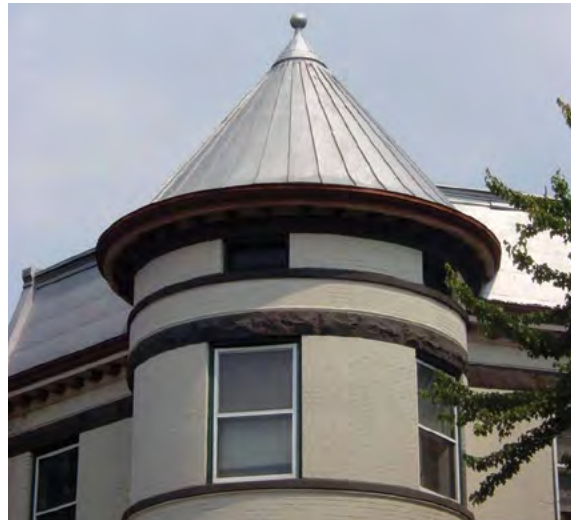
[6] A standing-seam sheet metal roof, like the one on the turret of this late 19th century row house, must be kept painted to ensure its preservation.

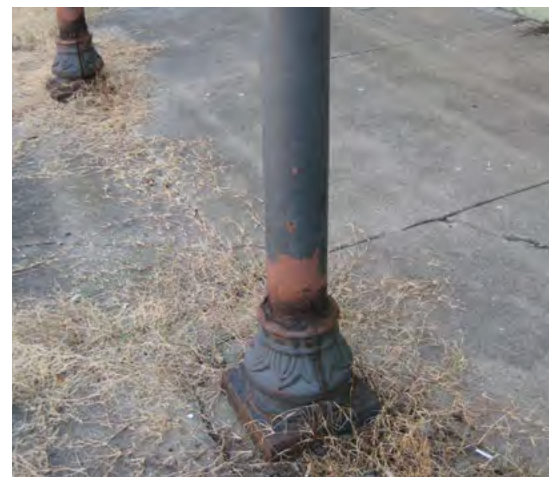
[7] (a) After the damaged portions of the base were repaired, (b) the cast-iron columns were cleaned and repainted to protect the metal from rusting.

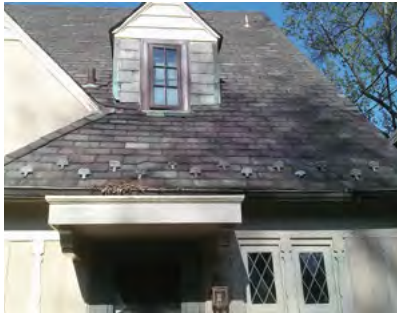
[8] Regular maintenance includes removing leaves that can clog gutters and cause water damage to the exterior and interior walls of a house.

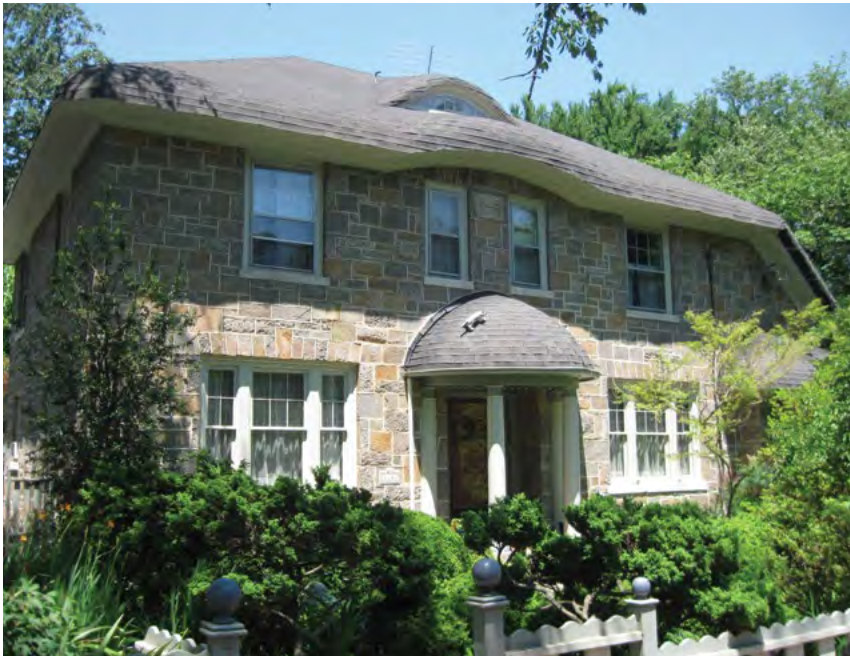
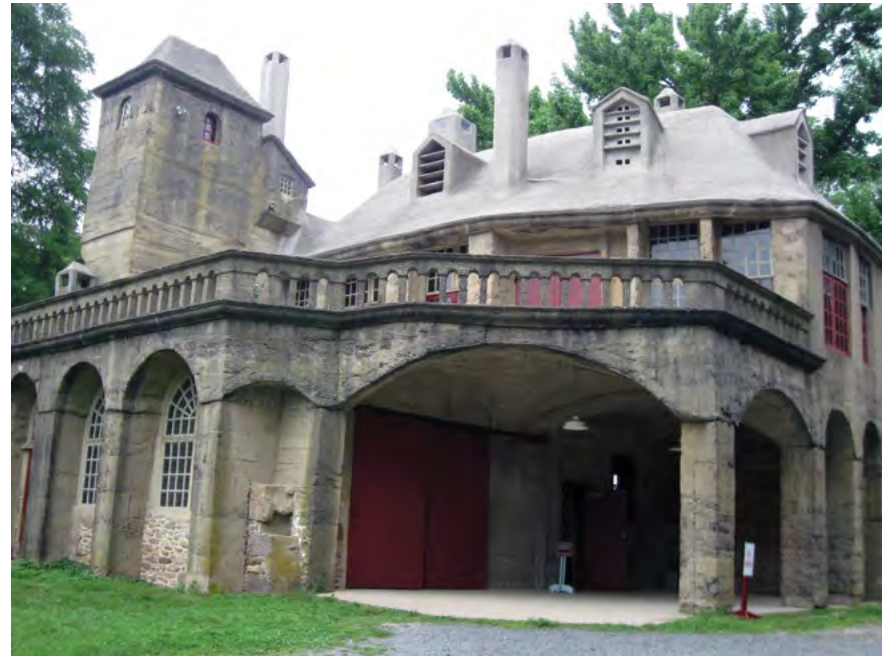
[9] Distinctively-shaped roofs are important in defining the historic character of these early 20th-century structures: (a) an asphalt shingle roof on a house; (b) and a concrete roof on Fonthill, Doylestown, PA (1908-1912), designed and built by Henry Chapman Mercer.

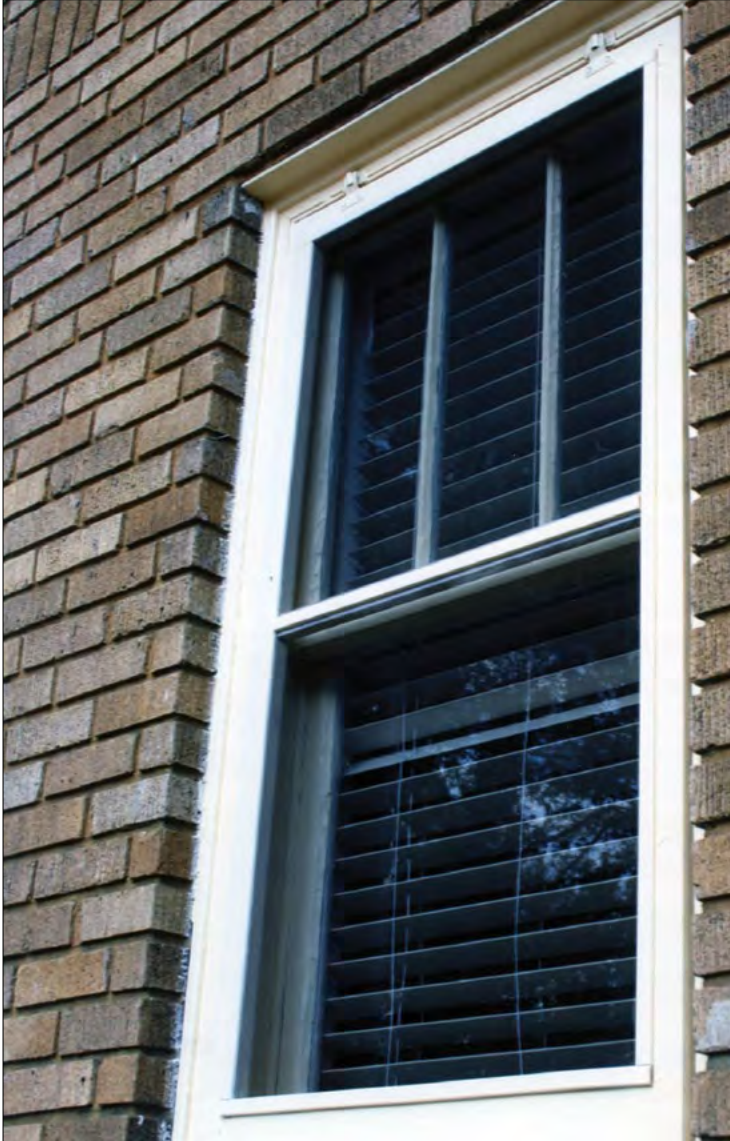
[10] Historic exterior storm windows preserve and help to insulate wood windows.

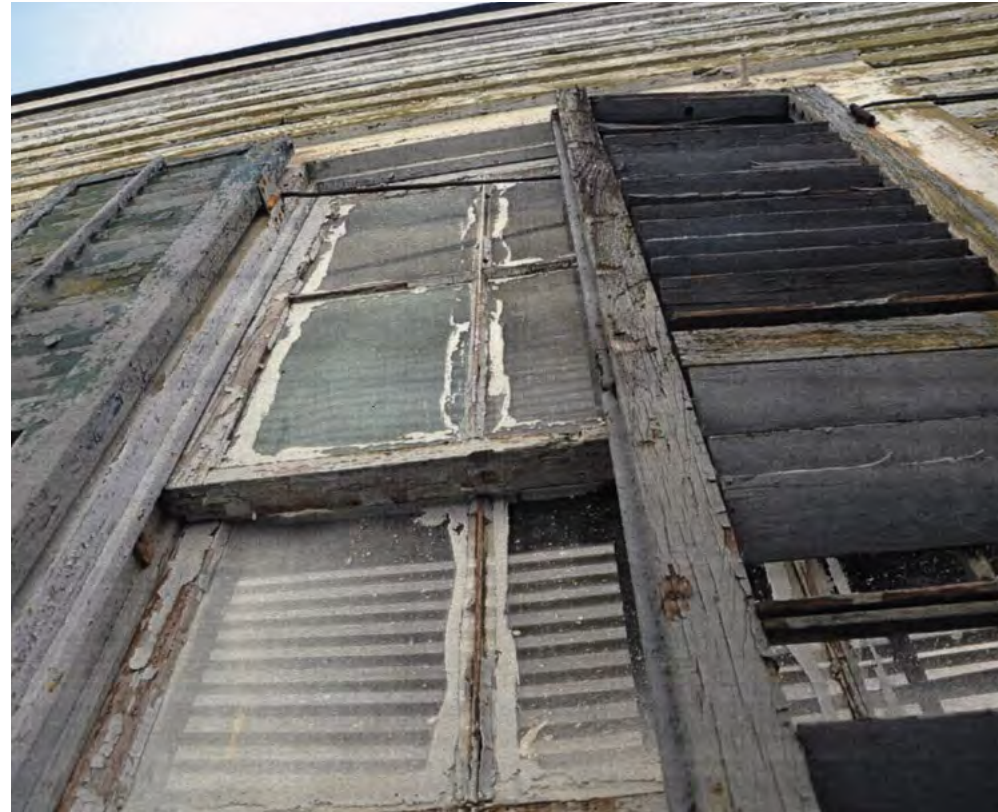
[11] Old and brittle glazing putty should be removed carefully before reputtying to keep window glazing weathertight.

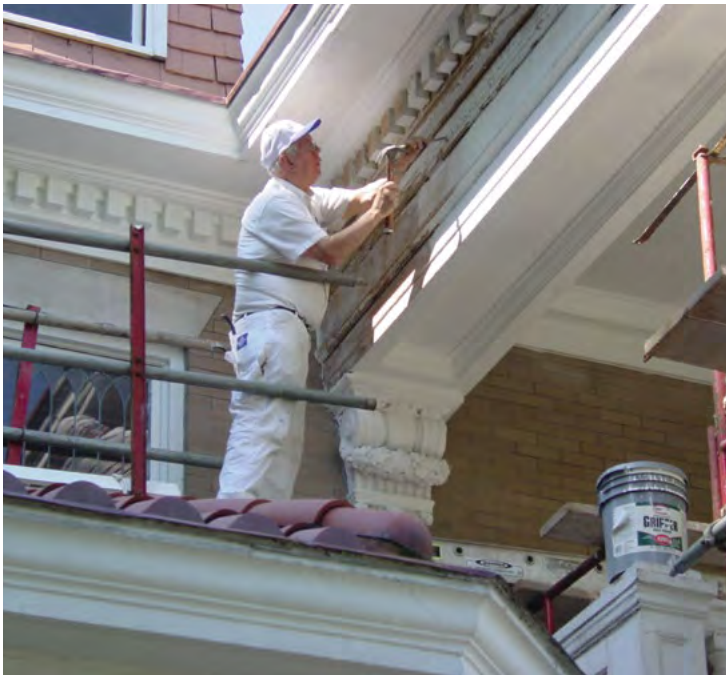
[13] It is important that exposed swallow tail porch rafters be kept painted to protect them from water damage.

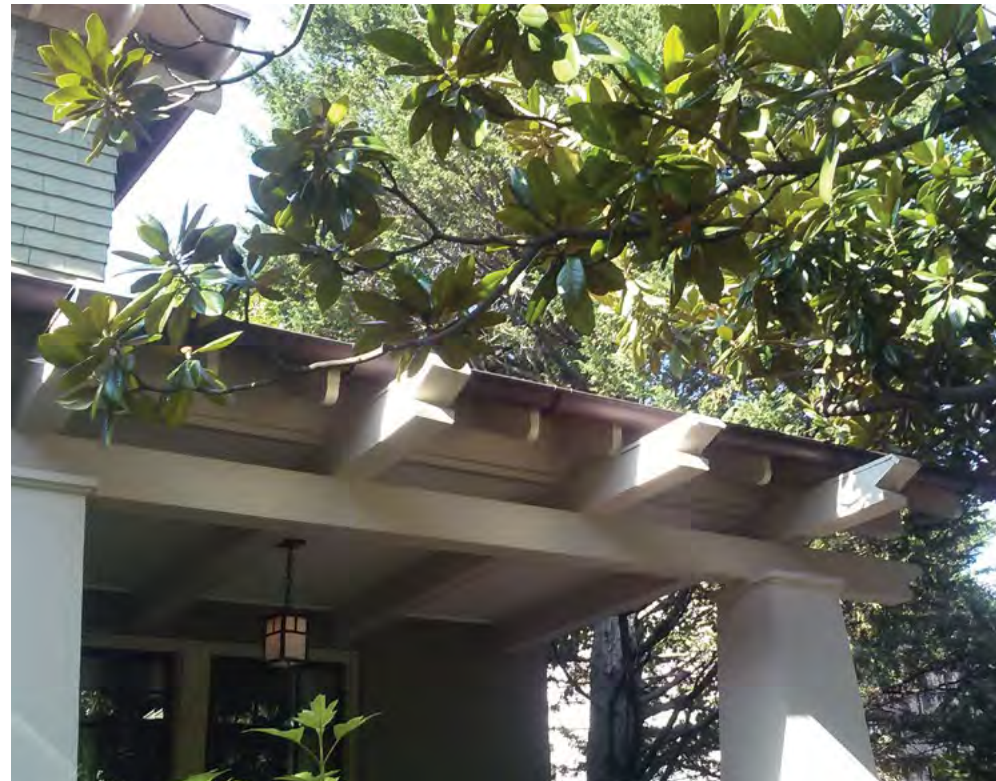
[12] Repair and limited replacement in kind to match deteriorated wood porch features is always a recommended preservation treatment.

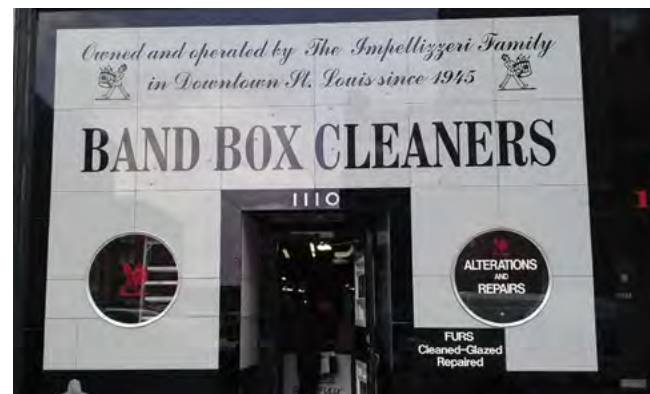
[14] The signage is an original and integral part of this historic Carrara glass storefront.

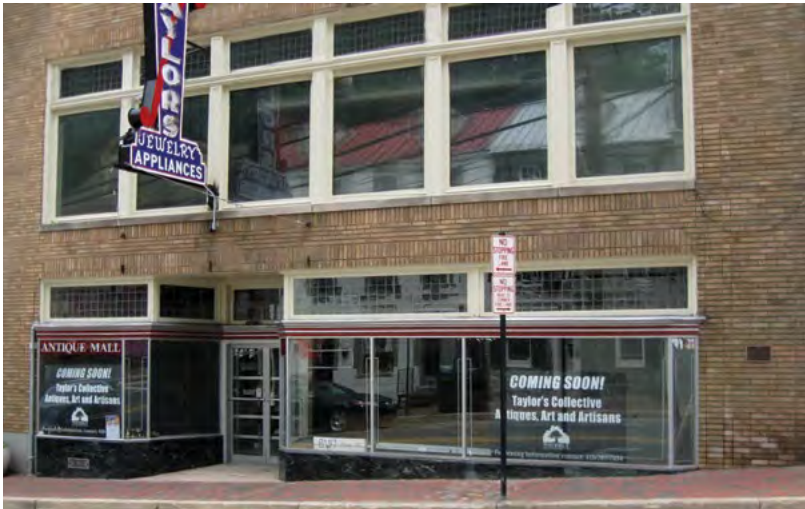
[15] Regular maintenance has helped to preserve this historic storefront, which retains all of its character-defining features, including the granite bulkhead, multi-paned transom glazing, and recessed entrance.

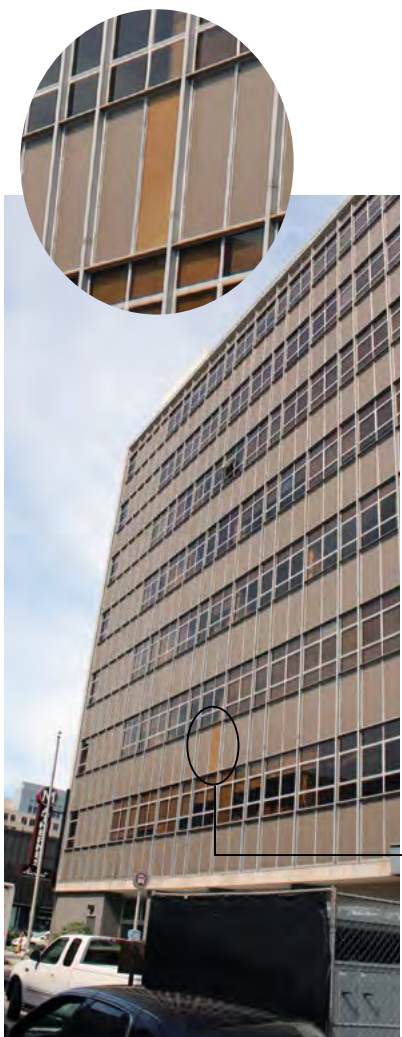
[16] Plywood provides temporary protection for an opening where a damaged spandrel panel was removed until a matching replacement panel can be installed.

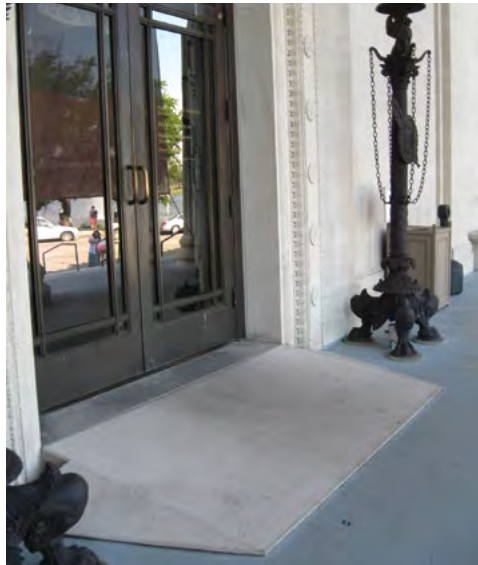
[26] A temporary ramp—unobtrusive and easily removed—facilitates access to the entrance of this museum and does not affect its historic character.

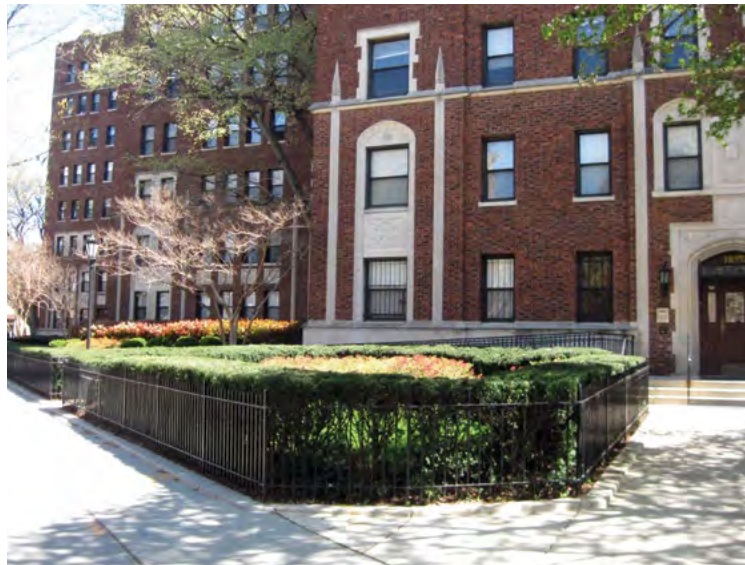
[27] The access ramp at the left of the entrance is concealed by a hedge which minimizes its visibility and impact on the character of the historic apartment building.

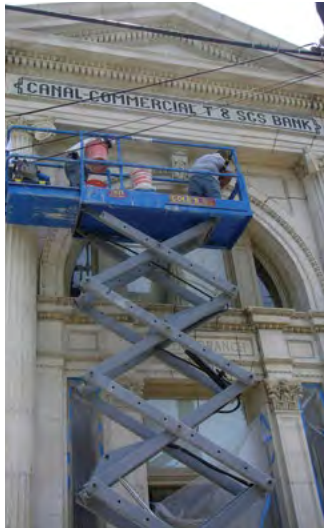
[1] An alkaline-based product is appropriate to use to clean historic marble because it will not damage the marble, which is acid sensitive.

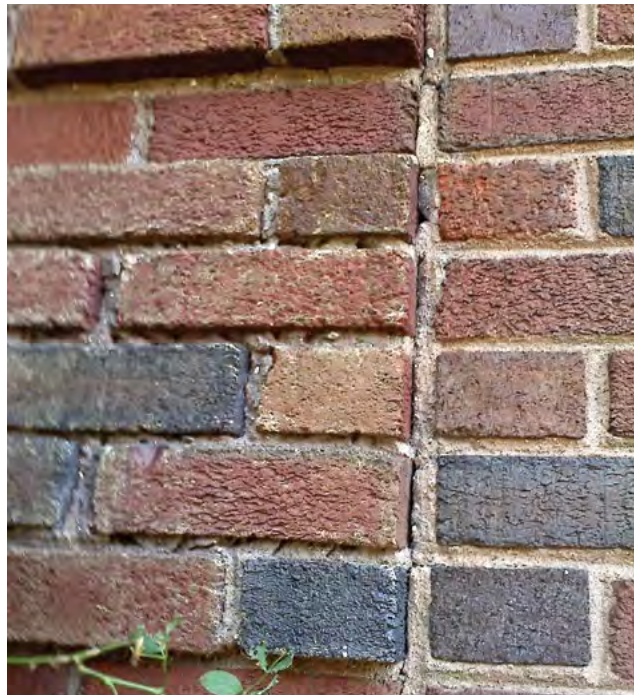
[4] Not Recommended:
The quoins on the left side of the photo show that high-pressure abrasive blasting used to remove paint can damage even early 20th-century, hard-baked, textured brick and erode the mortar, whereas the same brick on the right, which was not abrasively cleaned, is undamaged.

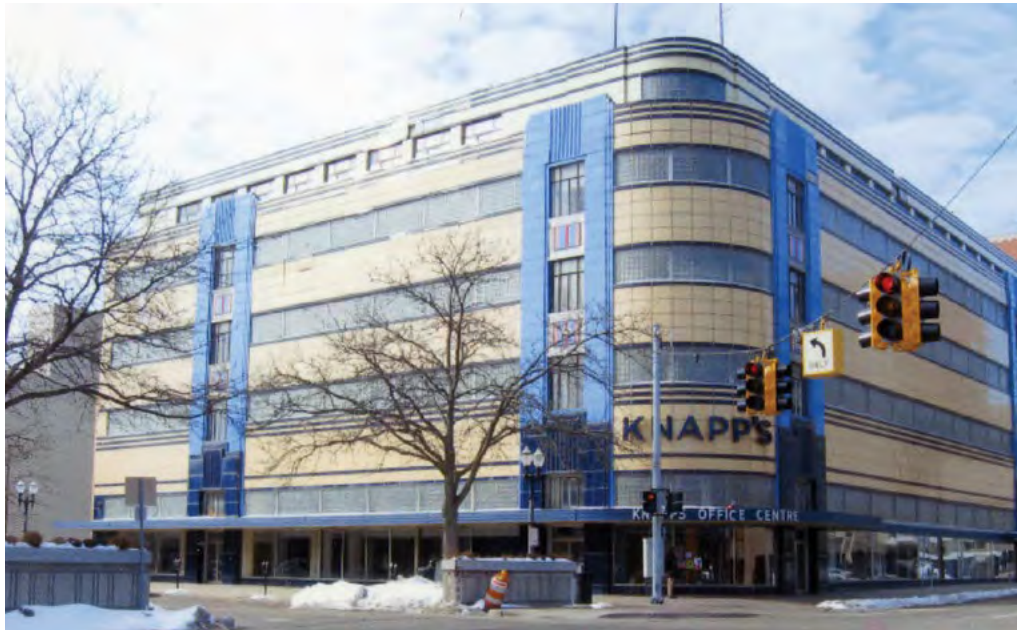
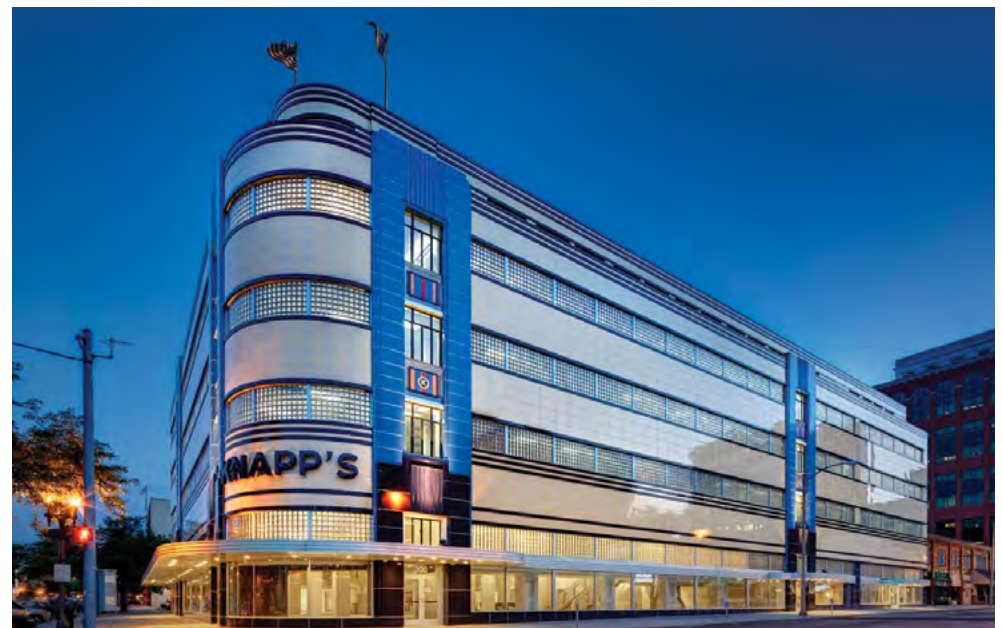
[7] (a) J.W. Knapp's Department Store, built 1937-38, in Lansing, MI, was constructed with a proprietary material named "Maul Macotta" made of enameled steel and cast-in-place concrete panels. Prior to its rehabilitation, a building inspection revealed that, due to a flaw in the original design and construction, the material was deteriorated beyond repair. The architects for the rehabilitation project devised a replacement system (b) consisting of enameled aluminum panels that matched the original colors (c). Photos and drawing (a-b): Quinn Evans Architects; Photo (c): James Haefner Photography.

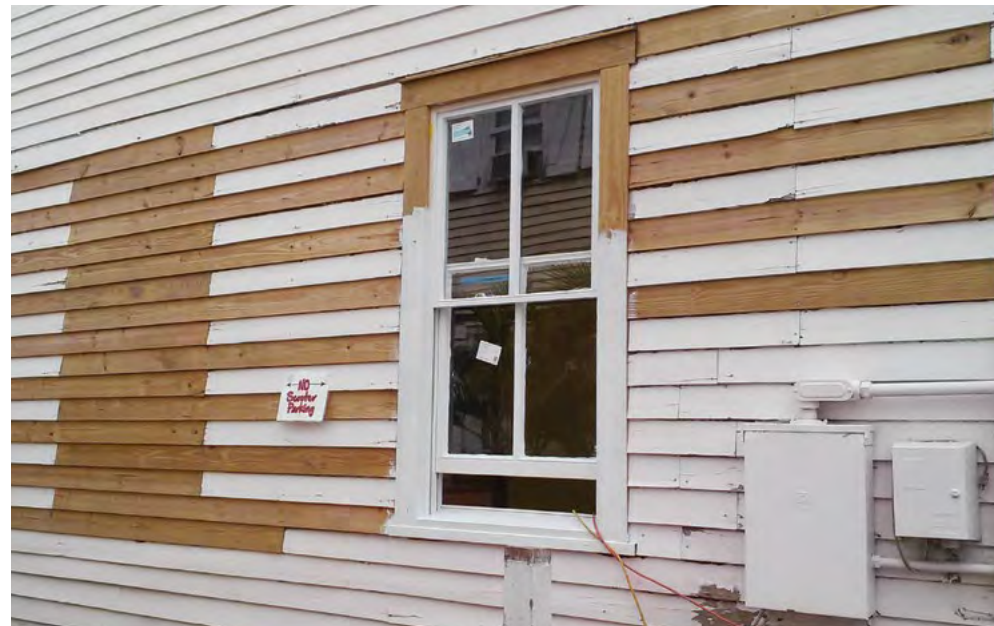
[8] Rotted clapboards have been replaced selectively with new wood siding to match the originals.

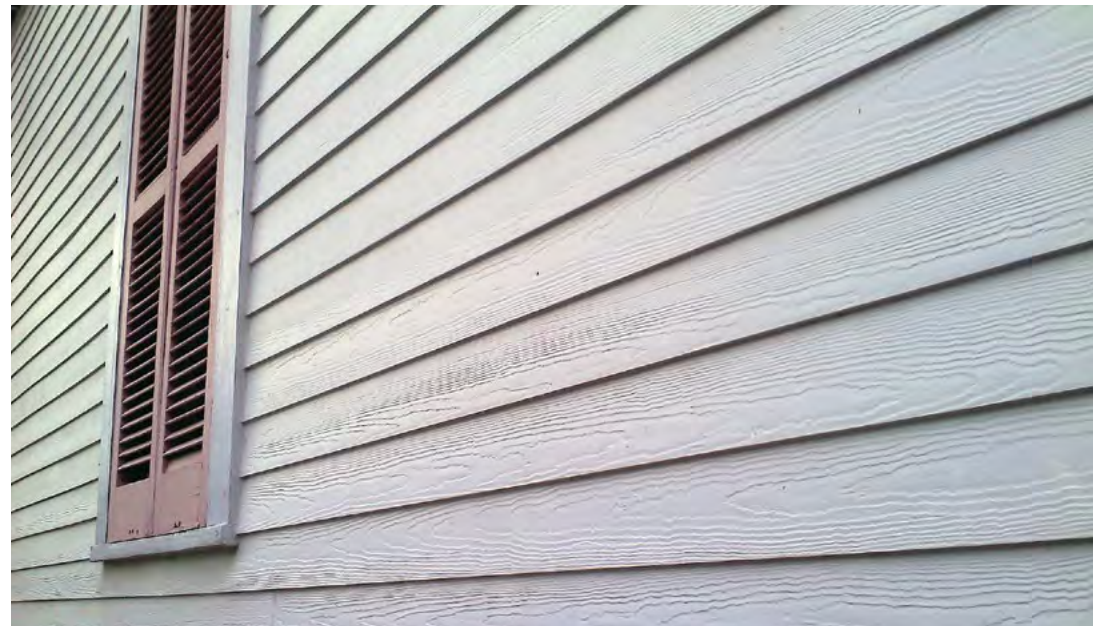
[10] Not Recommended:

Cementitious siding with a raised wood-grain texture is not an appropriate material to replace historic wood siding, which has a smooth surface when painted.

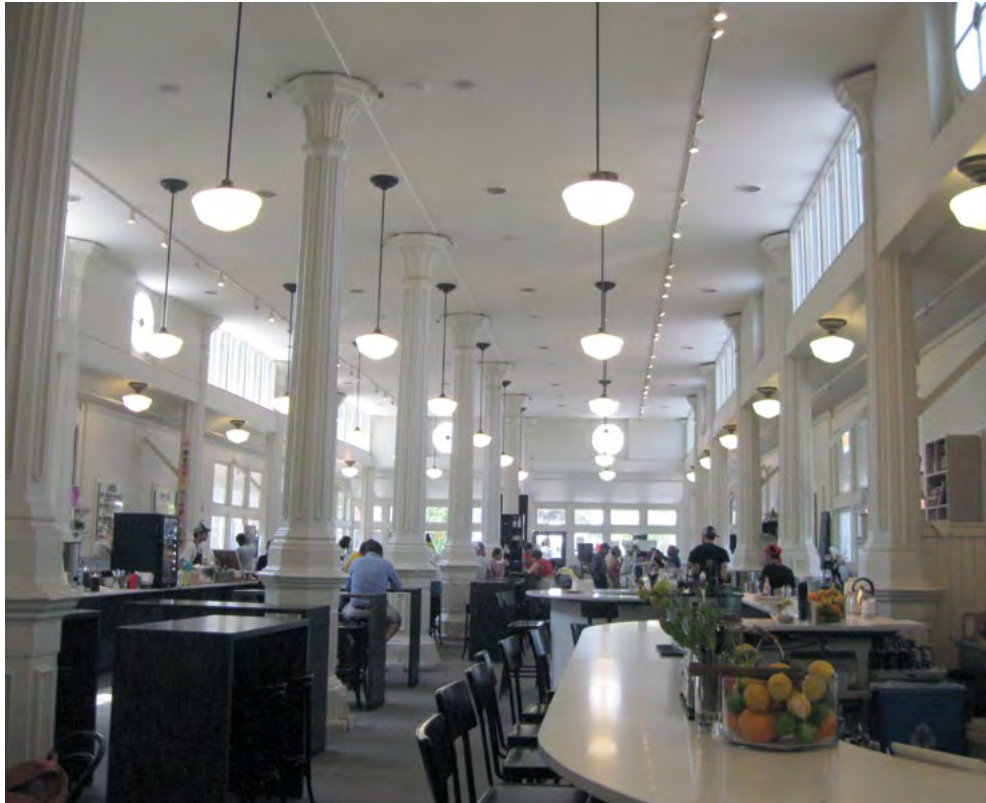
[14] Interior cast-iron columns have been cleaned and repainted as part of the rehabilitation of this historic market building for continuing use.

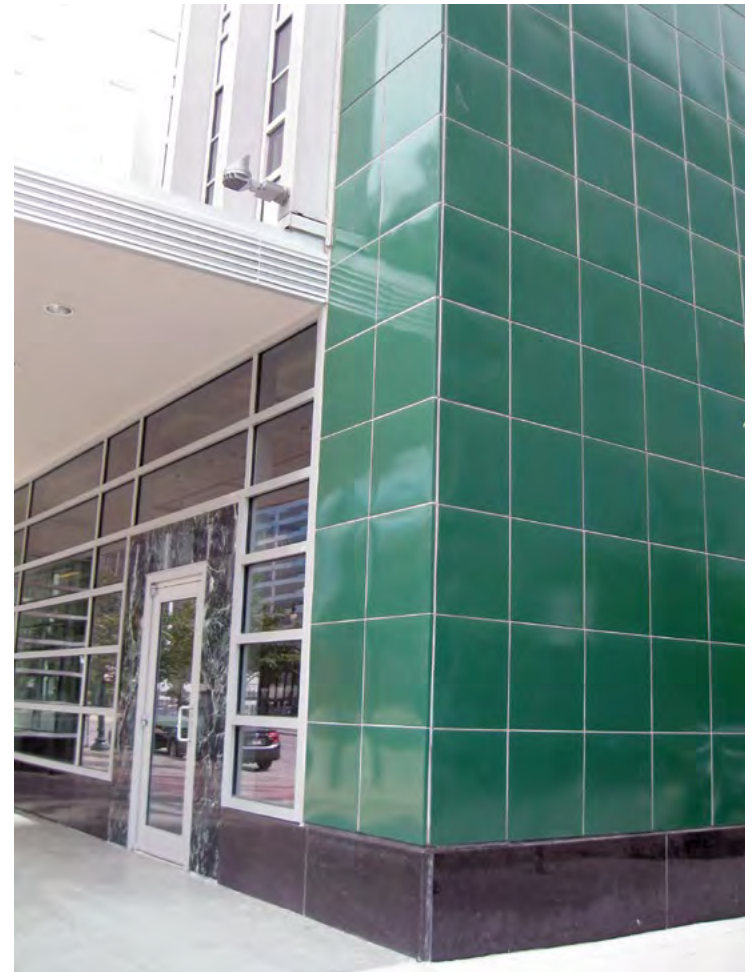
[15] New enameled-metal panels were replicated to replace the original panels, which were too deteriorated to repair, when the storefront of this early 1950s building was recreated.

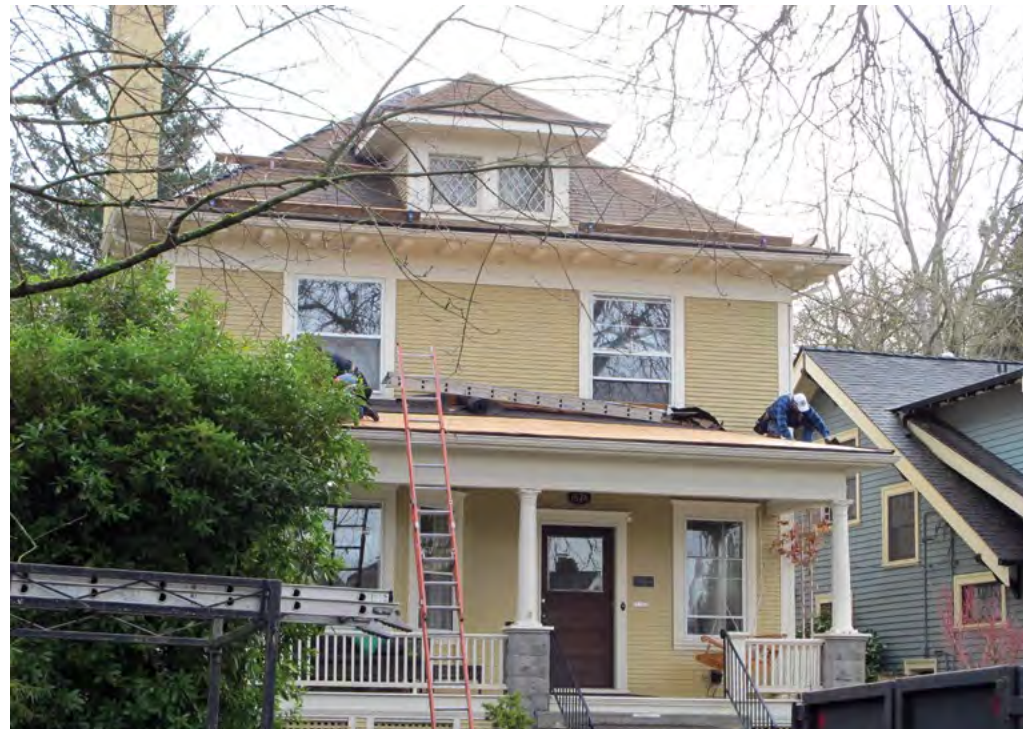
[16] The deteriorated asphalt shingles of this porch roof are being replaced in kind with matching shingles.

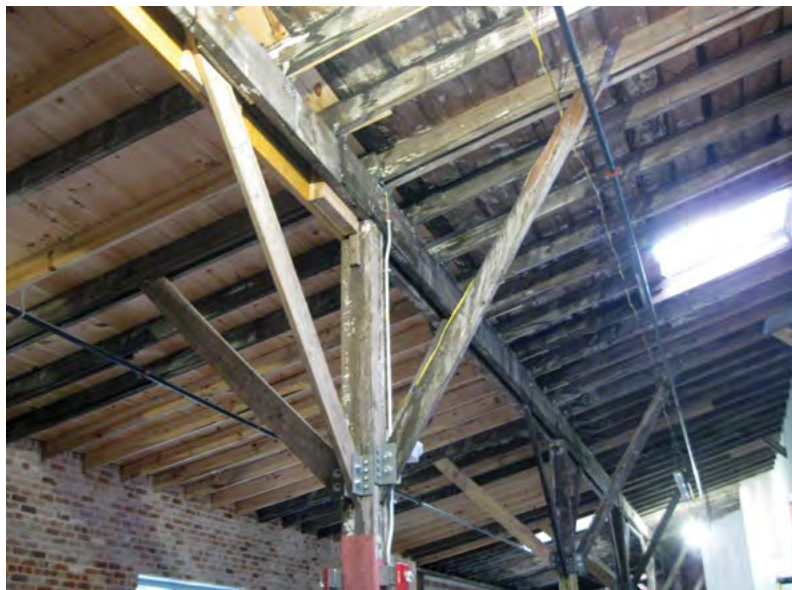
[17] New wood elements have been used selectively to replace rotted wood on the underside of the roof in this historic warehouse.

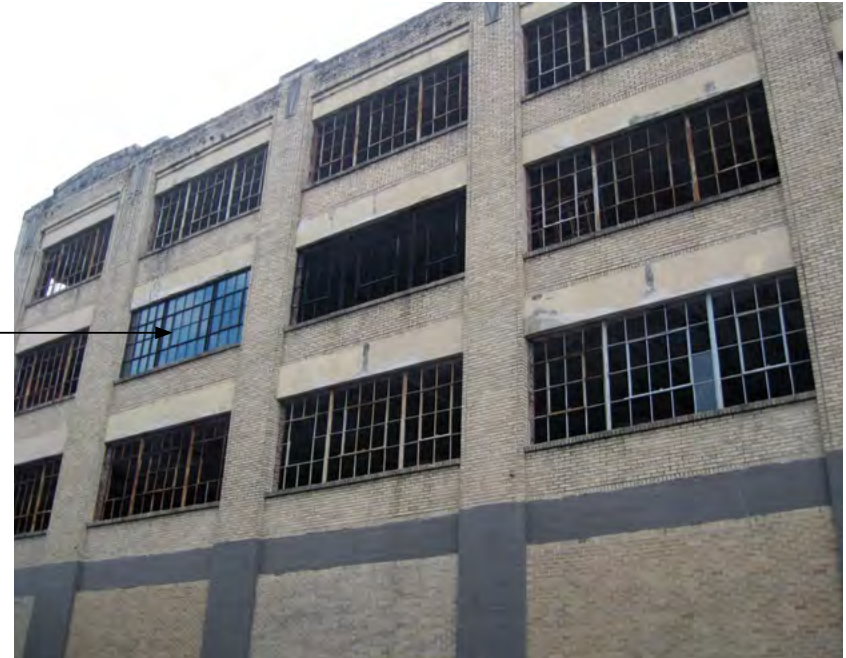
[19] Installing a mockup of a proposed replacement window can be helpful to evaluate how well the new windows will match the historic windows that are missing or too deteriorated to repair.

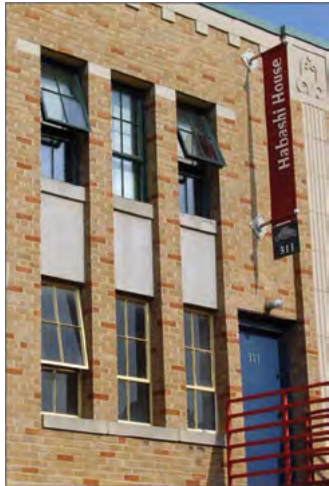
[21] The windows on the lower floor, which were too deteriorated to repair, were replaced with new steel windows matching the upper-floor historic windows that were retained.

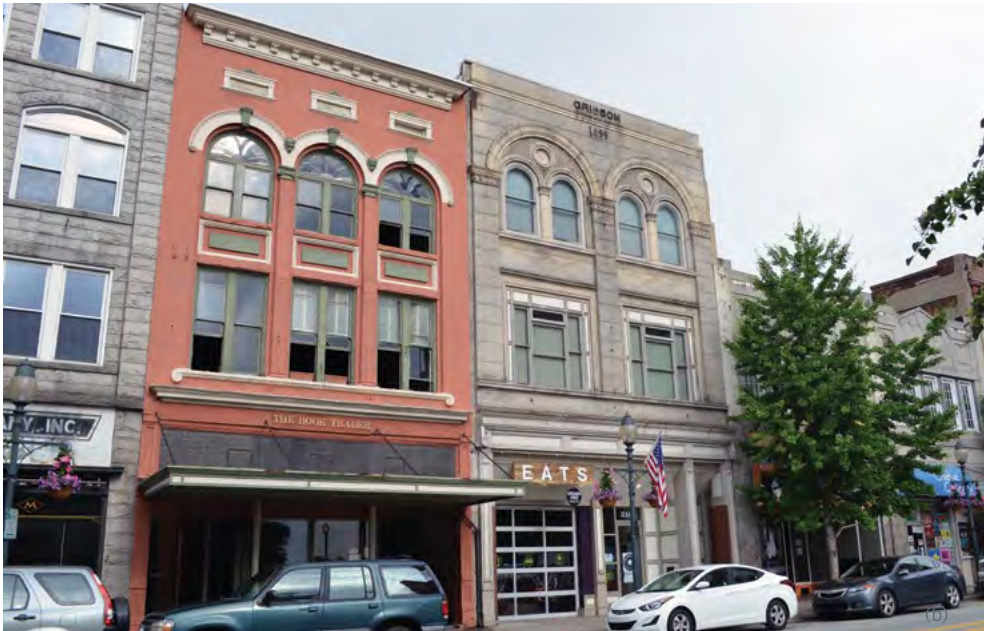
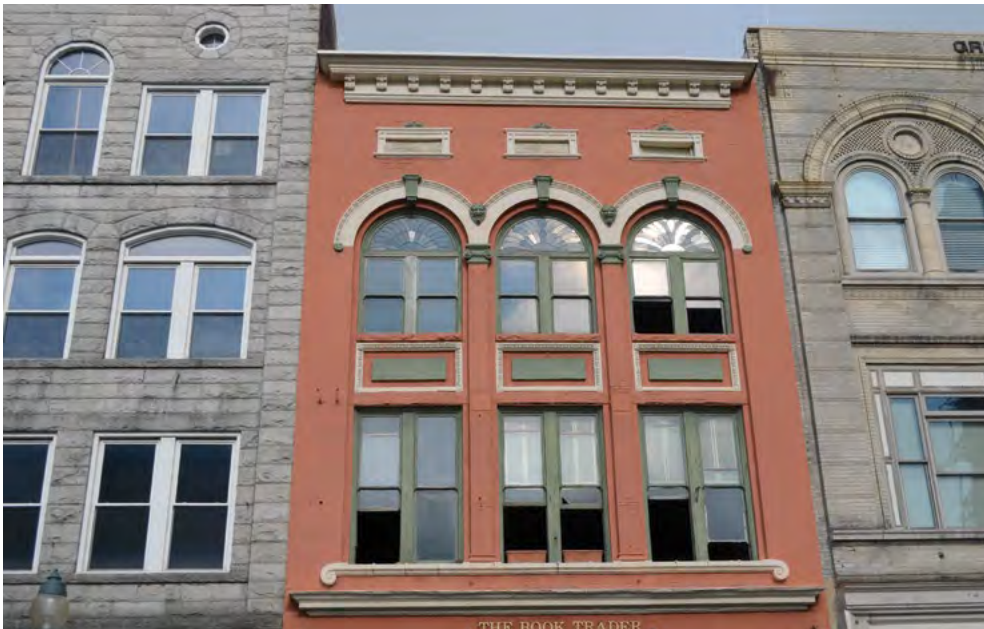
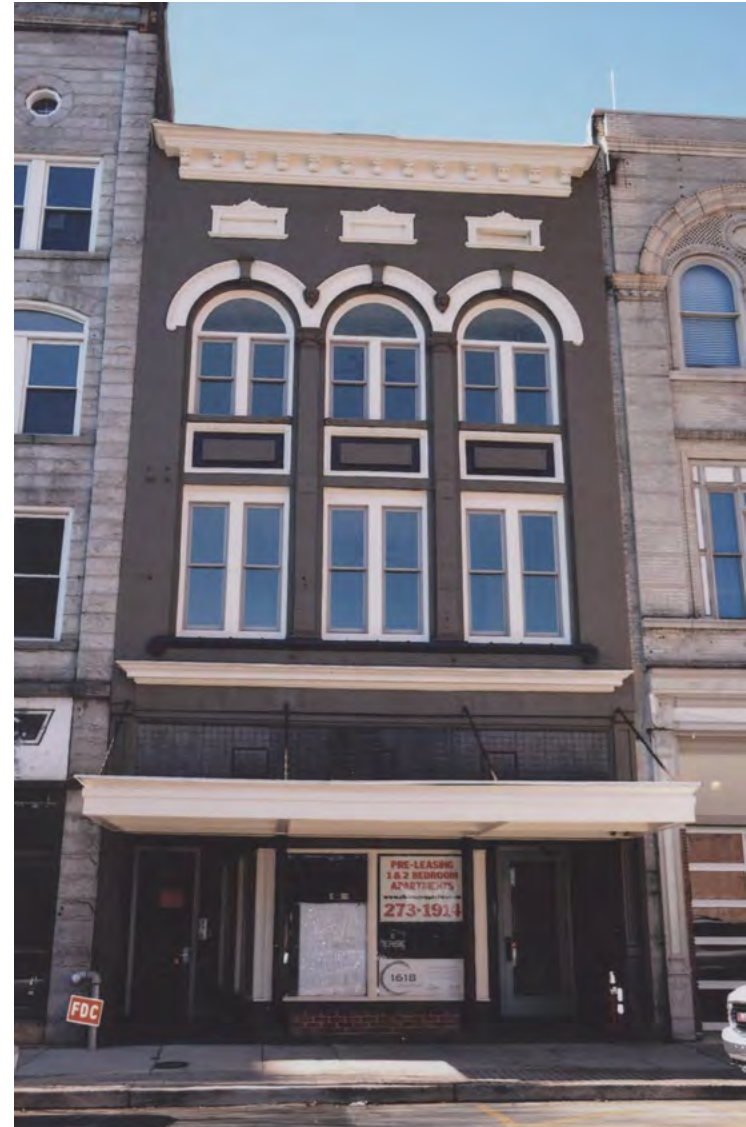
[22] **Not Recommended:** (a-b) The original wood windows in this late-19th-century building, which were highly decorative, could likely have been repaired and retained. (c) Instead, they were replaced with new windows that do not match the detailing of the historic windows and, therefore, do not meet the Standards (above).

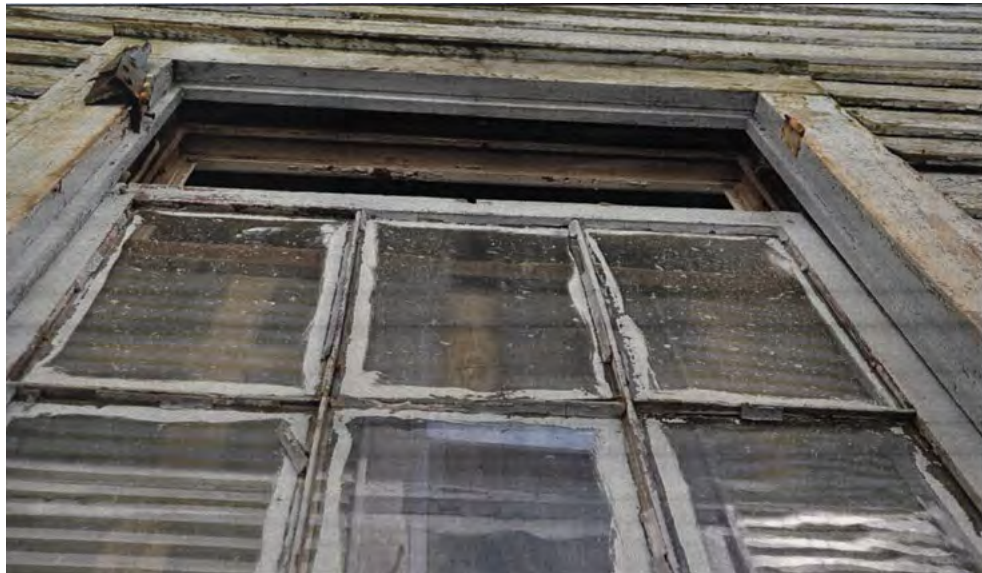
[23] (a) This deteriorated historic wood window was repaired and retained (b) in this rehabilitation project.

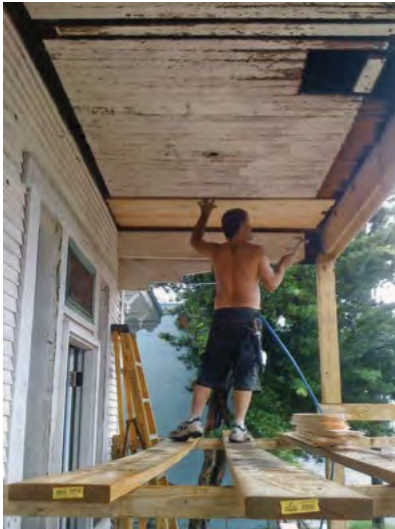
[24] Rotted boards in the beaded-board porch ceiling are being replaced with new matching beaded board.

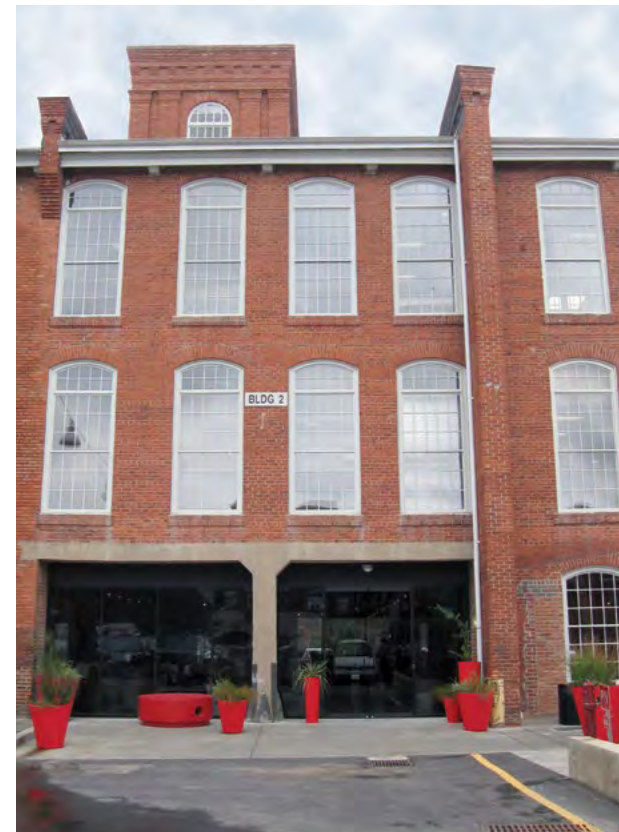
[25] The new infill designs for the garage door openings in this commercial building (a) converted for restaurant use and in this mill building (b) rehabilitated for residential use are compatible with the historic character of the buildings.

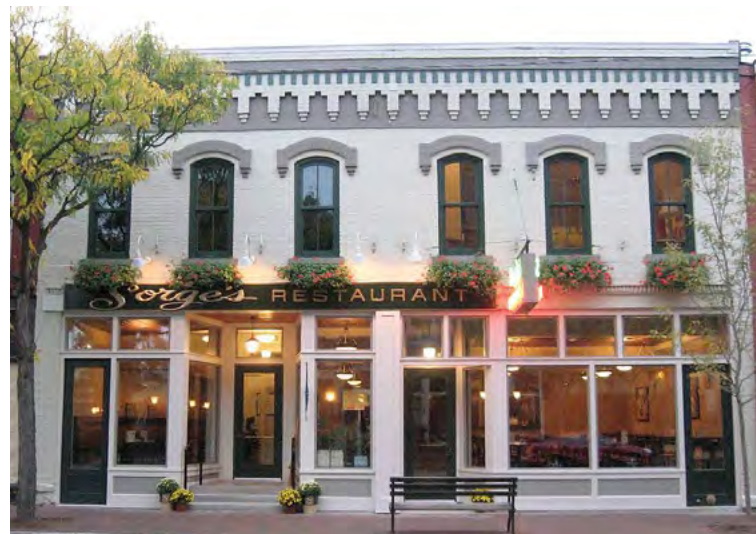
[28] This new storefront, which replaced one that was missing, is compatible with the historic character of the building.

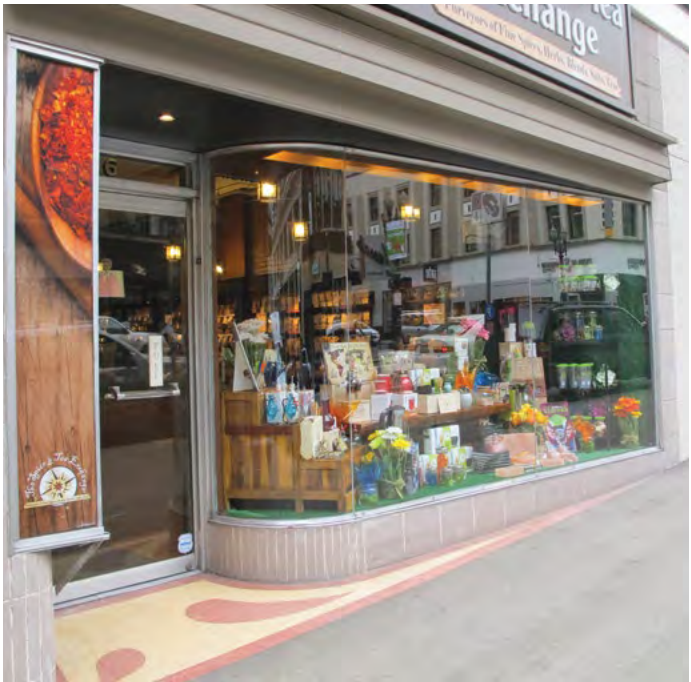
[27] This original c. 1940s storefront, with its character-defining angled and curved glass display window and recessed entrance with a decorative terrazzo paving, is in good condition and should be retained in a rehabilitation project.

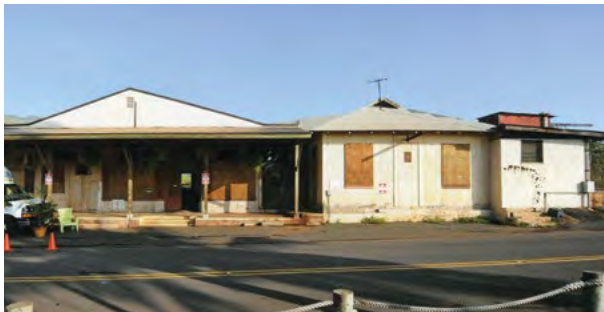
[29] The rehabilitation of the 1910 Māālaea General Store (a), which served the workers' camp at the Wailuku Sugar Company on the Hawaiian island of Maui, included the reconstruction of the original parapet (b).

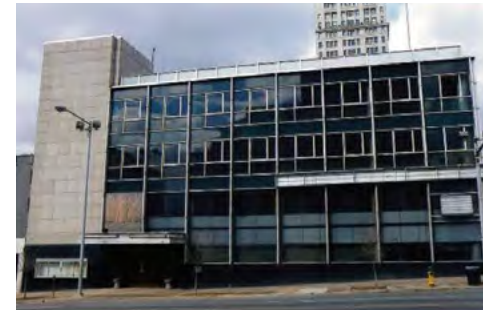
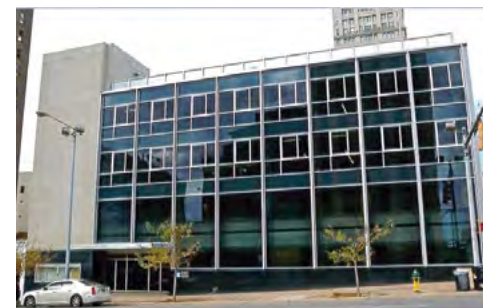
[31 a-c:] (a) The rehabilitation of the First Federal Savings and Loan Association building in Birmingham, AL, constructed in 1961, required replacing the deteriorated historic curtain wall system because the framing and the fasteners holding the spandrel glass and the windows had failed. (b) Comparative drawings show that the differences between the replacement system, which incorporated new insulated glass to meet wind-load requirements, and the original system are minimal. (c) The replacement system, shown after completion of the project, has not altered the historic character of the building.

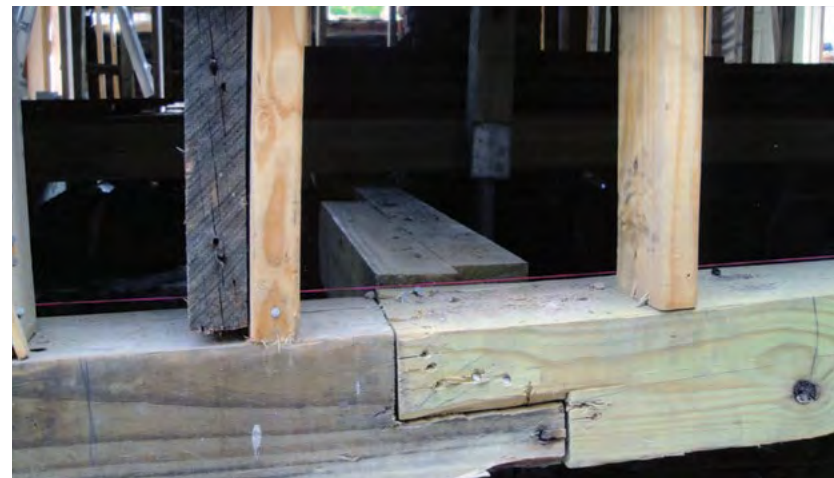
[33] Retaining as much as possible of the historic wood sill plate and replacing only the termite-damaged wood is always the preferred and recommended treatment.

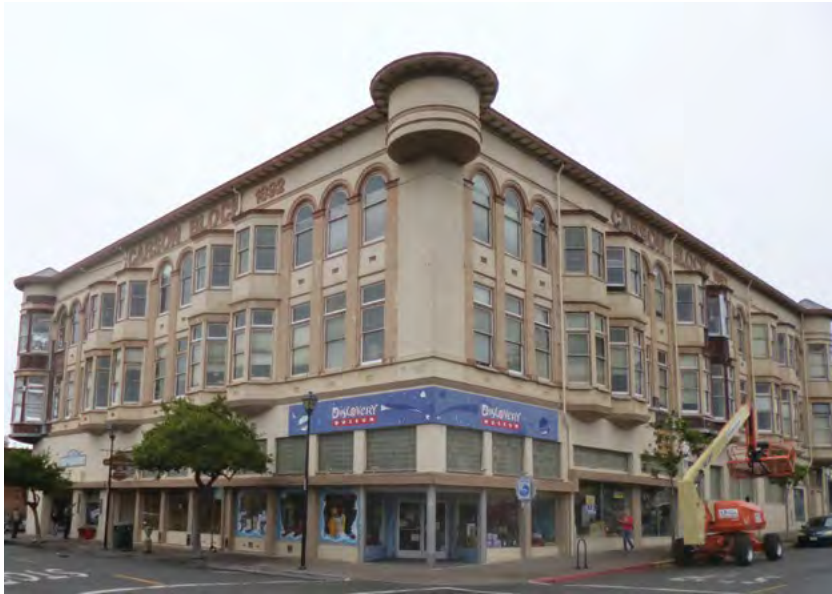
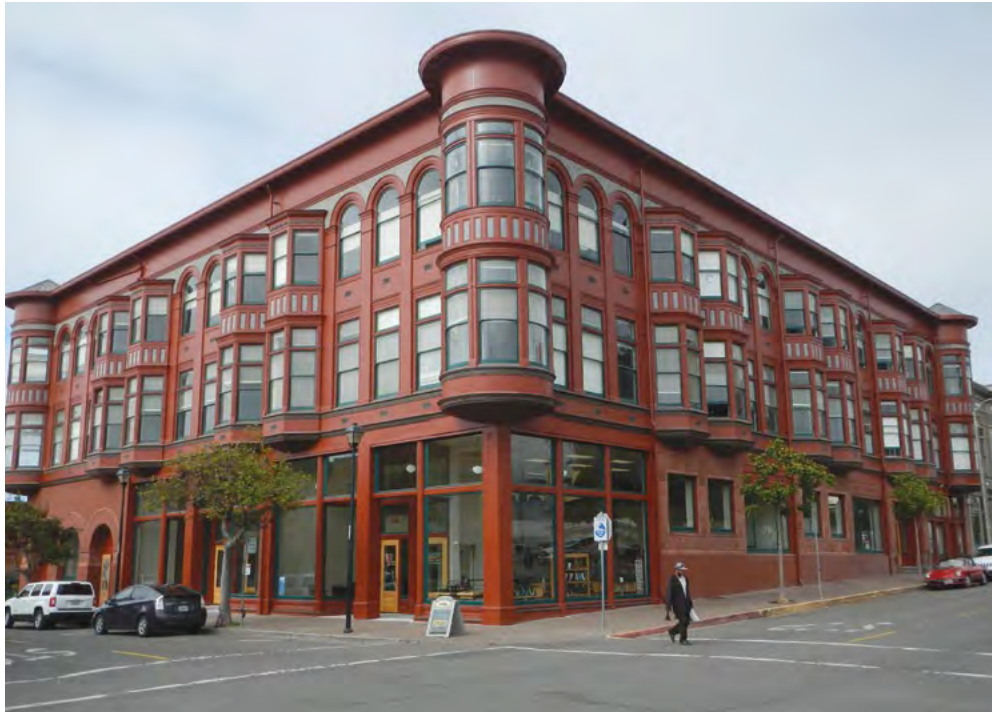
[32] (a-b) The rehabilitation of the 1892 Carson Block Building in Eureka, CA, for its owner, the Northern California Indian Development Council, included recreating the missing corner turret and sensitively introducing seismic reinforcement (c) shown here (opposite page) in a secondary upper floor office space. Photos: Page & Turnbull.
