**Historic Preservation Commission (HPC) Agenda
Tuesday March 21, 2023 5:30 PM
Minturn Town Hall / 302 Pine St Minturn, CO**

The purpose of *The Secretary of the Interior's Standards for the Treatment of Historic Properties and Guidelines for Preserving, Rehabilitating, Restoring and Reconstructing Historic Buildings* is to provide guidance to historic building owners and building managers, preservation consultants, architects, contractors, and project reviewers prior to beginning work. It is always recommended that preservation professionals be consulted early in any project.

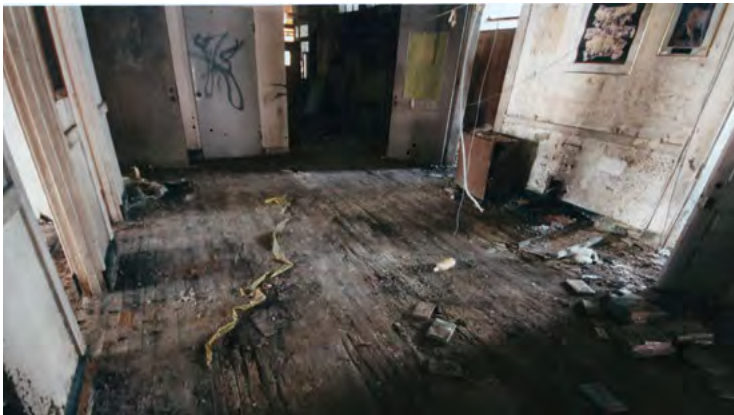
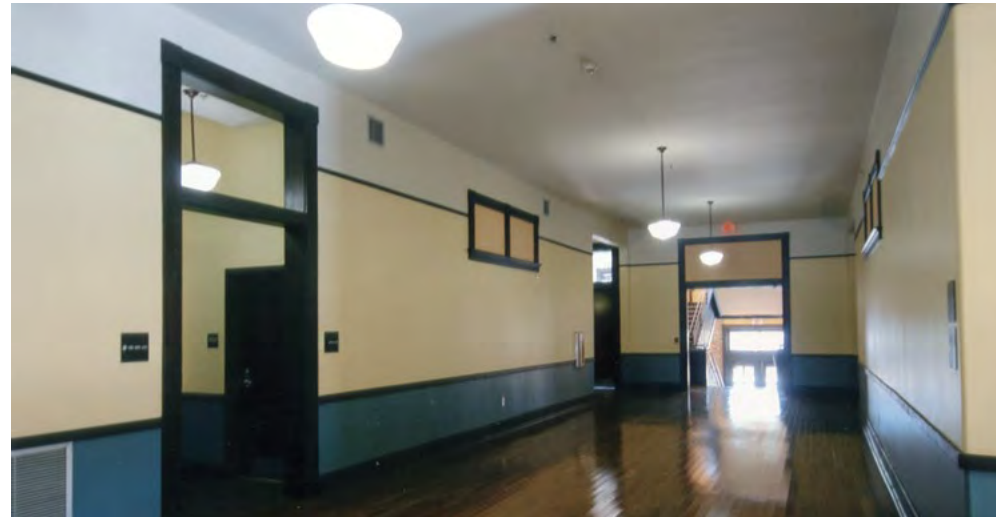
[35] (a) Although deteriorated, the historic school corridor, shown on the left, with its character-defining features, including doors and transoms, was retained and repaired as part of the rehabilitation project (b).

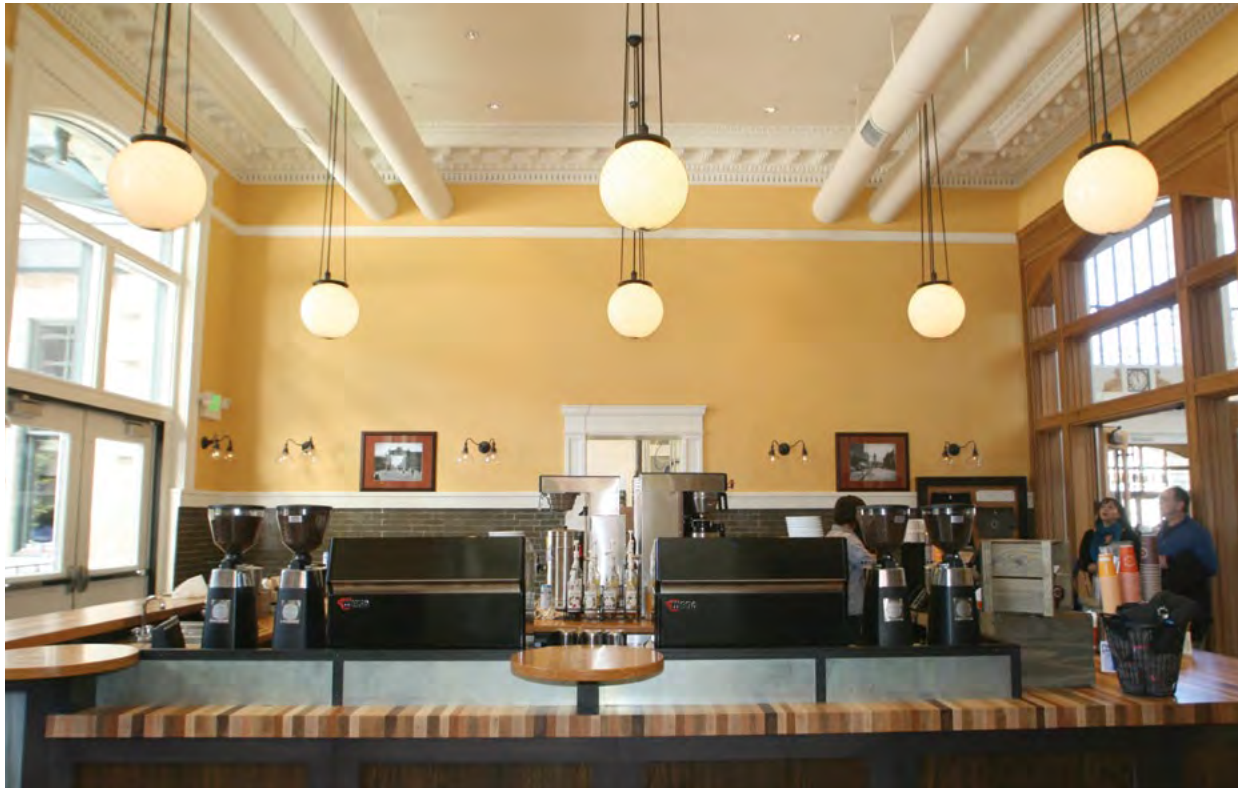
[37] Exposed and painted ducts were appropriately installed here in a retail space in Denver's historic Union Station after considering other options that would have impacted the ceiling height, or damaged or obscured the ornamental plaster crown molding. *Photo: Heritage Consulting Group.*

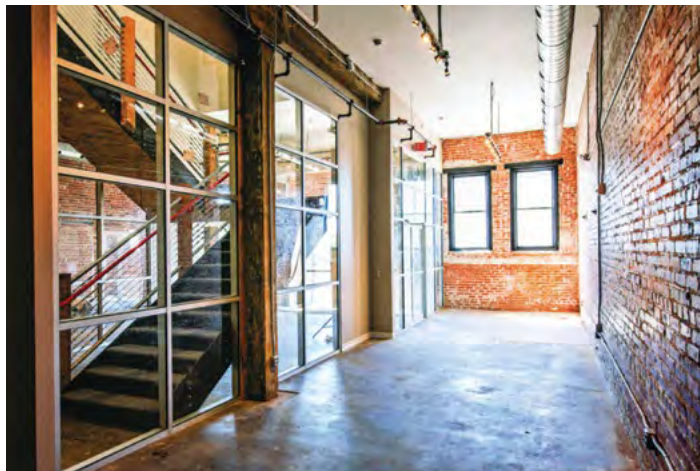
[38] The rehabilitation project retained the industrial character of this historic factory building, which included installation of a fire-rated, clear glass enclosure that allows the stairway, an important interior feature, to remain visible.

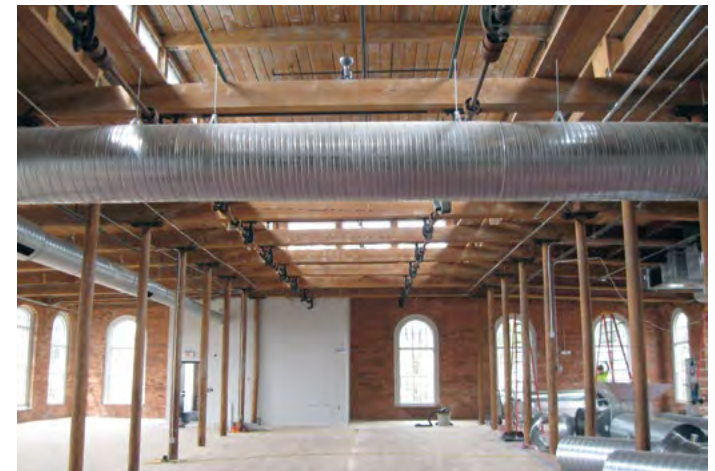
[39] Leaving the ceiling structure exposed and installing exposed ductwork where it does not impact the windows, are appropriate treatments when rehabilitating an industrial building for another use.

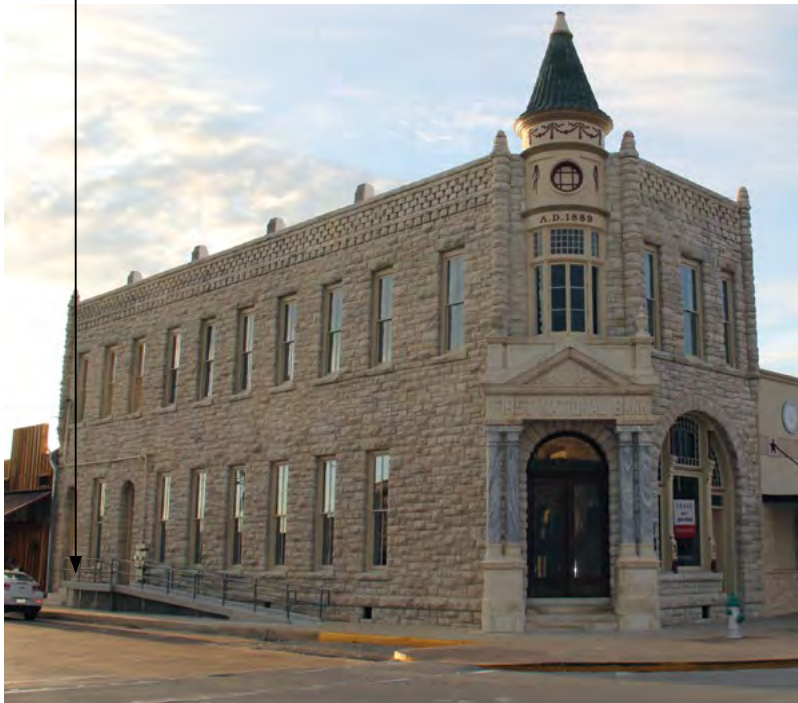
[52] The access ramp blends in with the stone façade of the First National Bank in Stephenville, TX, and is appropriately located on the side where it does not impact the historic character of the building. Photo: Nancy McCoy, QuimbyMcCoy Preservation Architecture, LLP.

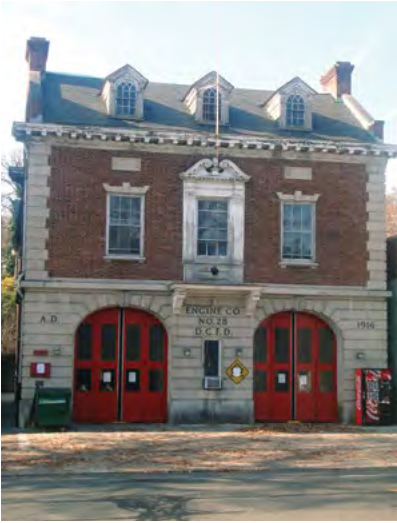
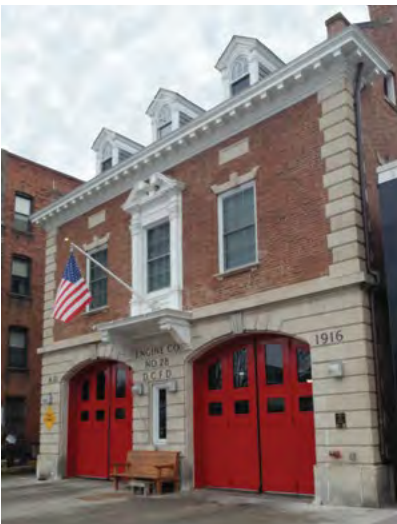
[56 a-b] In order to continue in its historic use, the door openings of this 1916 Colonial Revival-style fire station had to be widened to accommodate the larger size of modern fire trucks. Although this resulted in some change to the arched door surrounds, it is minimal and does not negatively impact the historic character of the building. (a) Above, before; Photo: Fire and Emergency Medical Services Department (FEMS), Washington, D.C.; below, after.

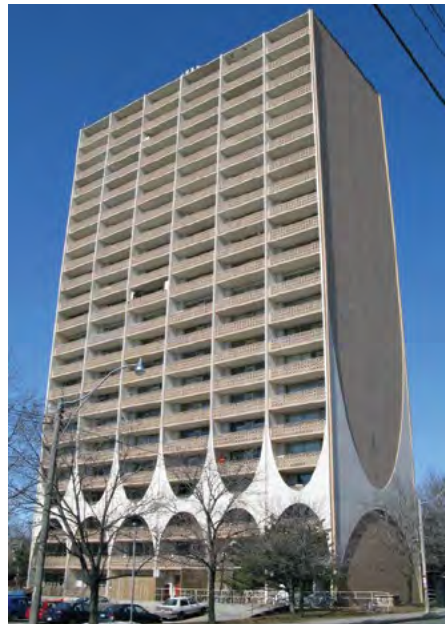
[59] (a-b) The decorative concrete balcony railings on this 1960s building did not meet life-safety code requirements. They were replaced with new glass railings with a fritted glass pattern matching the original design—a creative solution that satisfies codes, while preserving the historic appearance of the building when viewed from the street (c-d). Photos: (a, b, d) ERA Architects, Inc.; (c) Nathan Cyprys, photographer.

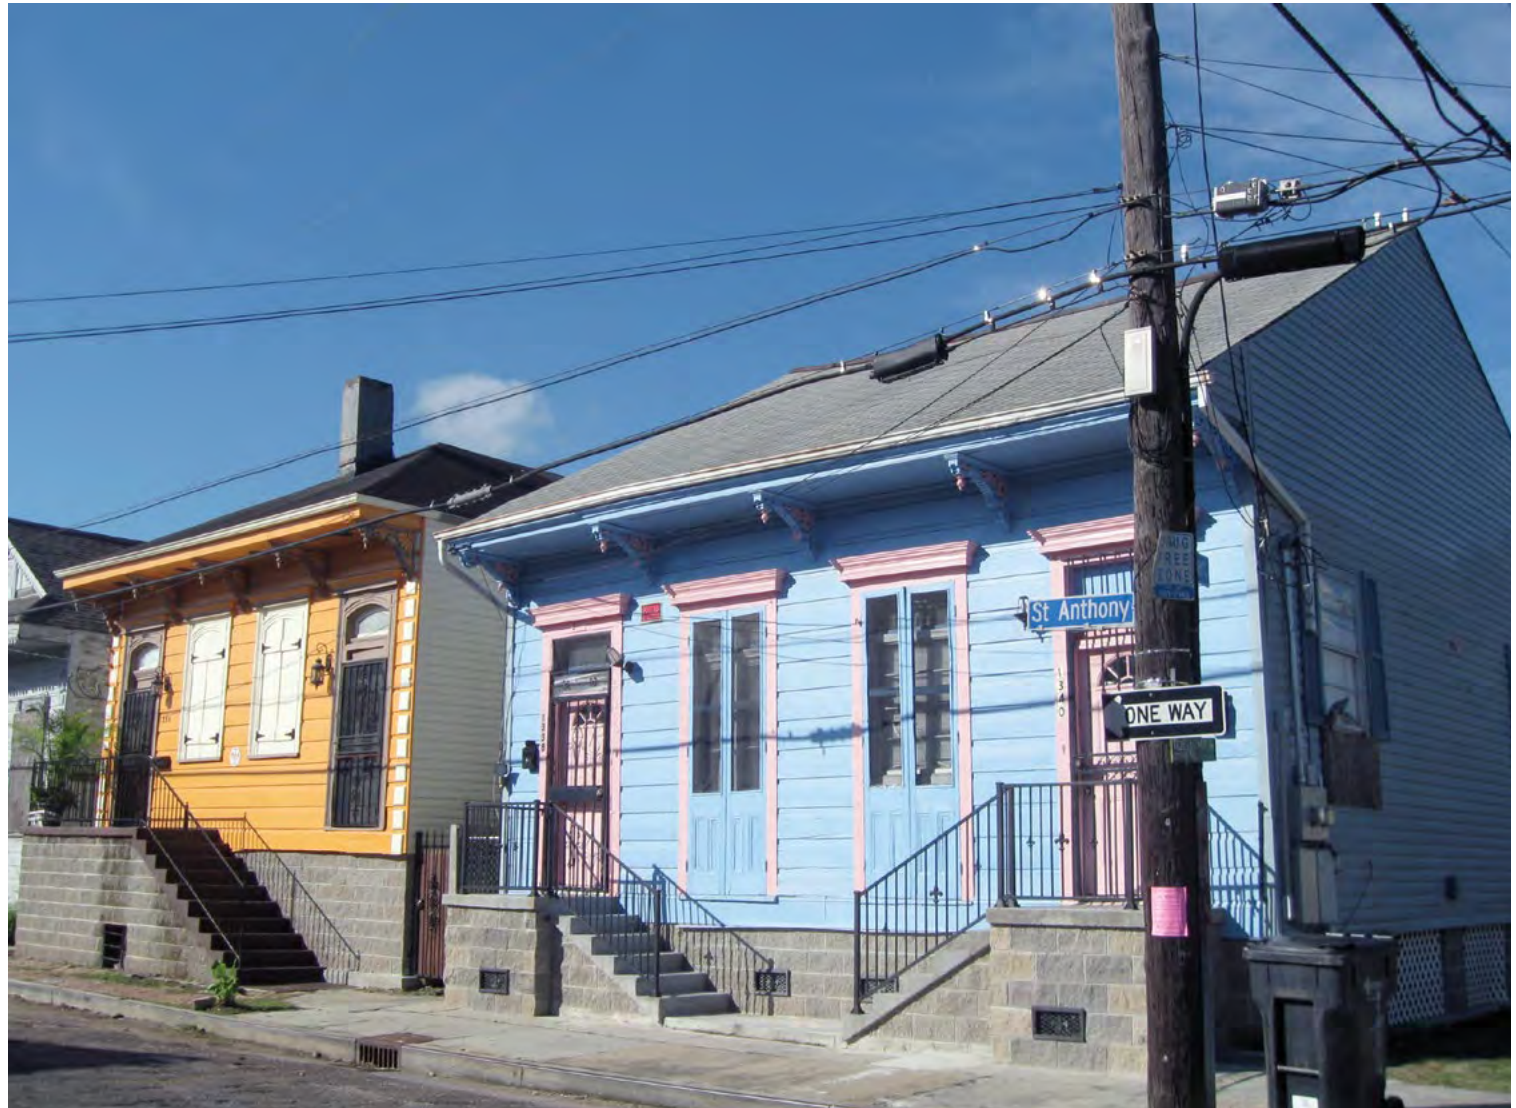
[60] In some instances, it may be necessary to elevate a historic building located in a floodplain to protect it. But this treatment is appropriate only if elevating the building will retain its historic character, including its relationship to the site, and its new height will be compatible with surrounding buildings if in a historic district. The house on the right, which has been raised only slightly, has retained its historic character. The house on the left has been raised several feet higher, resulting in a greater impact on the historic character of the house and the district.

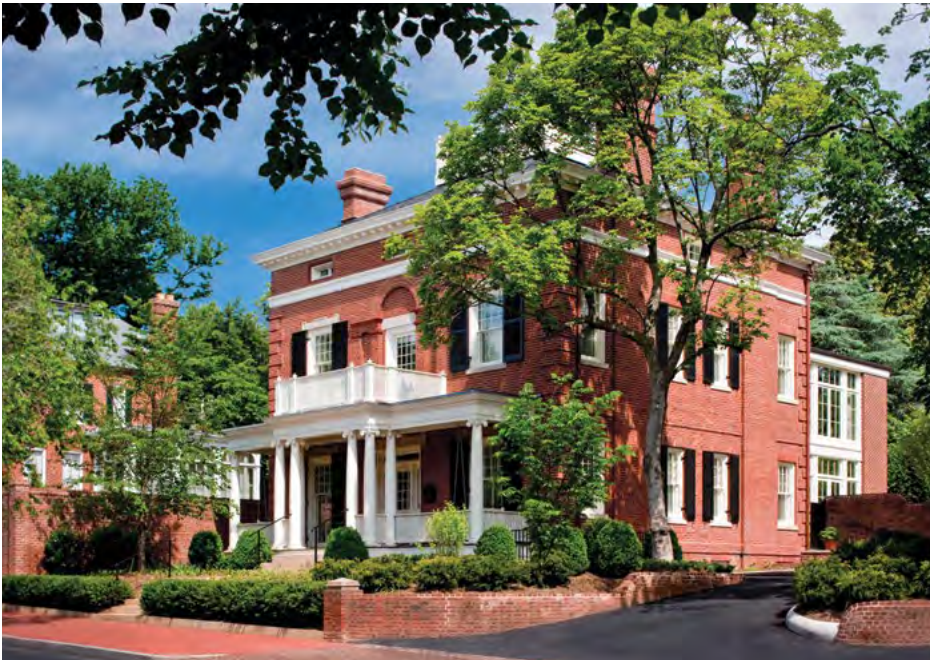
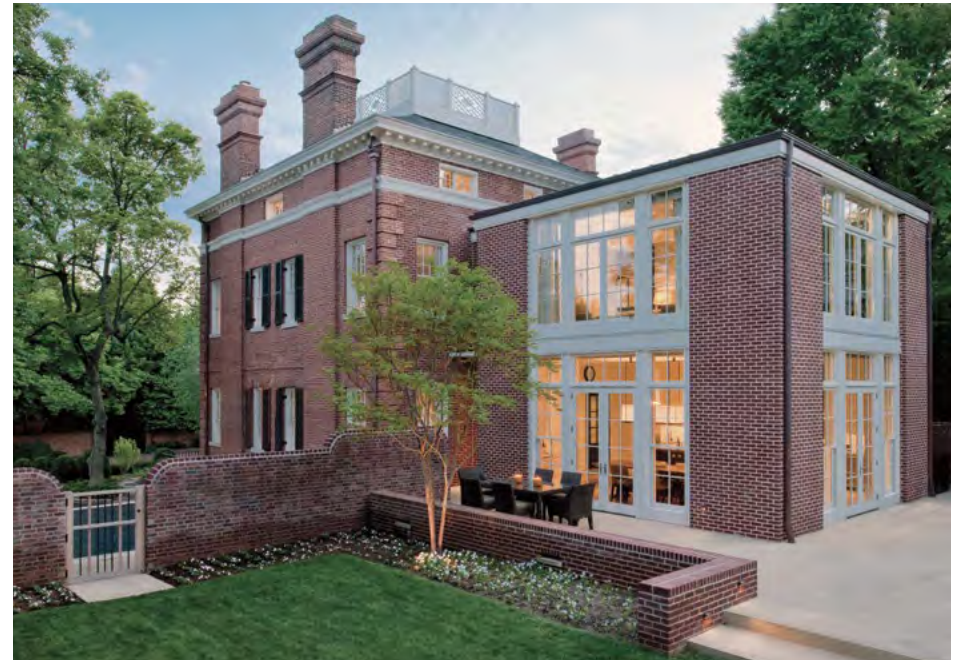
[61 a-b] The materials, design, and location at the back of the historic house are important factors in making this a compatible new addition. Photos: © Maxwell MacKenzie.

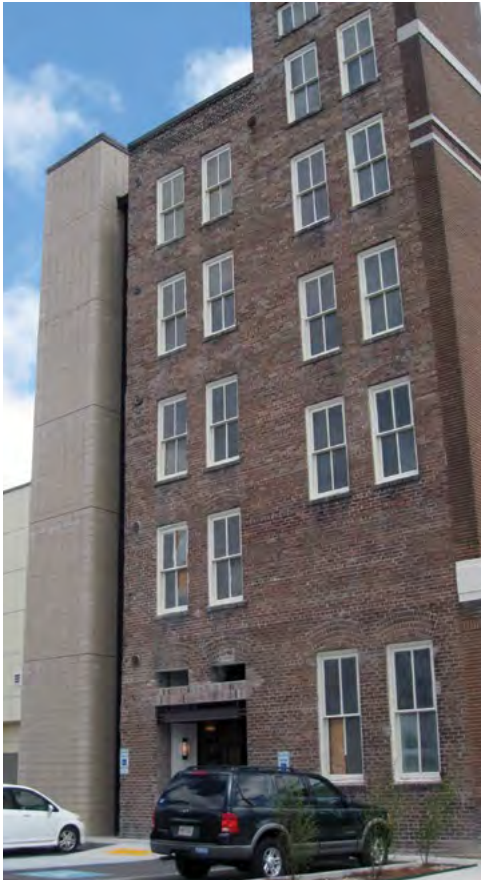
[62] The stair tower at the rear of this commercial building is a compatible new addition.

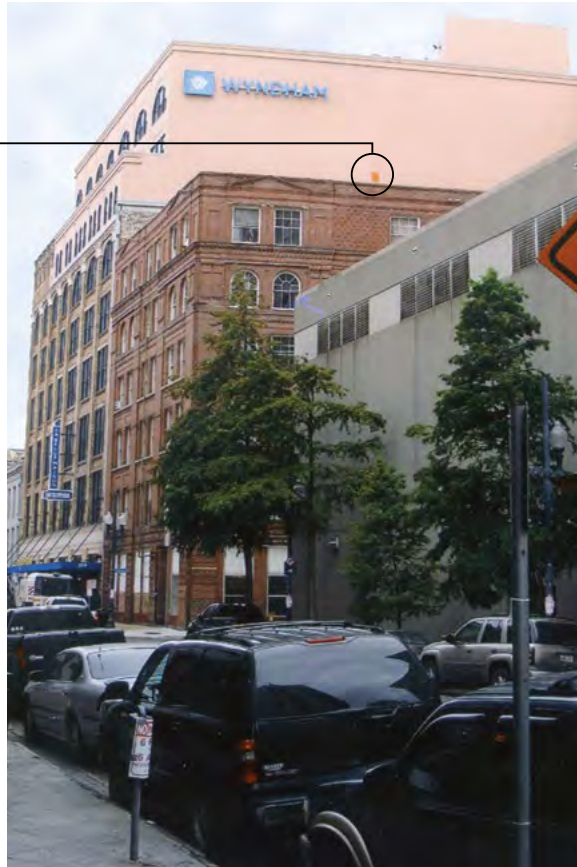
[63] (a) A mockup should be erected to demonstrate the visibility of a proposed rooftop addition and its potential impact on the historic building. Based on review of this mockup (orange marker), it was determined that the rooftop addition would meet the Standards (b). The addition is unobtrusive and blends in with the building behind it.

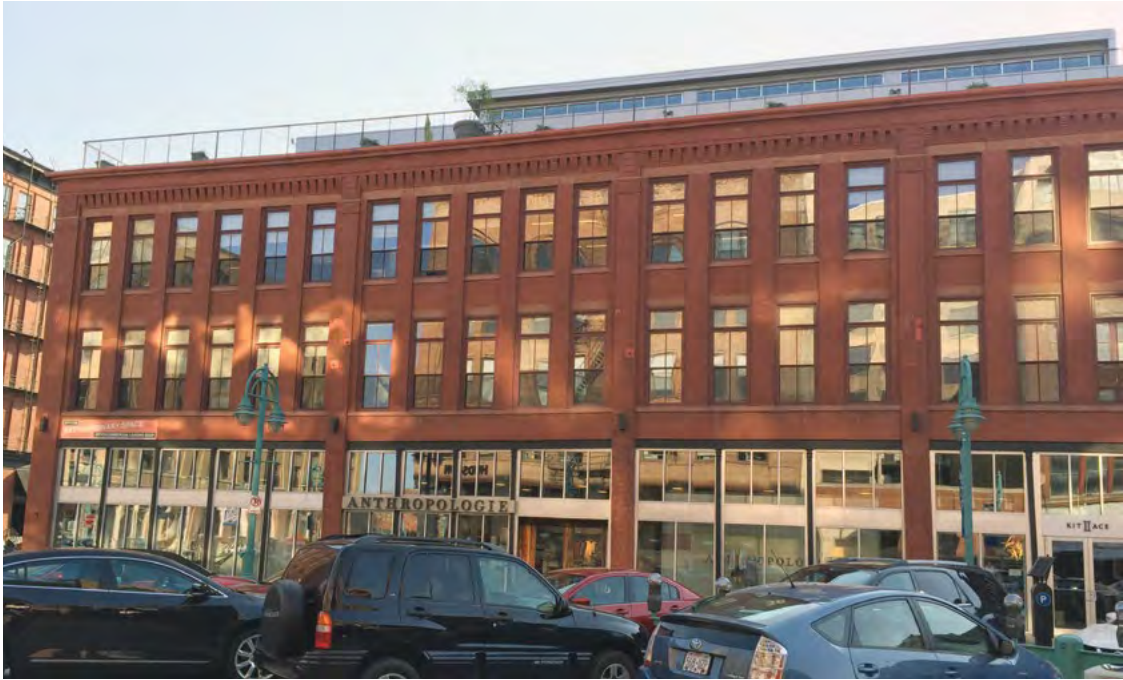
[64] Not Recommended:
It is generally not appropriate to construct a rooftop addition on a low-rise, two- to three-story building such as this, because it negatively affects its historic character.

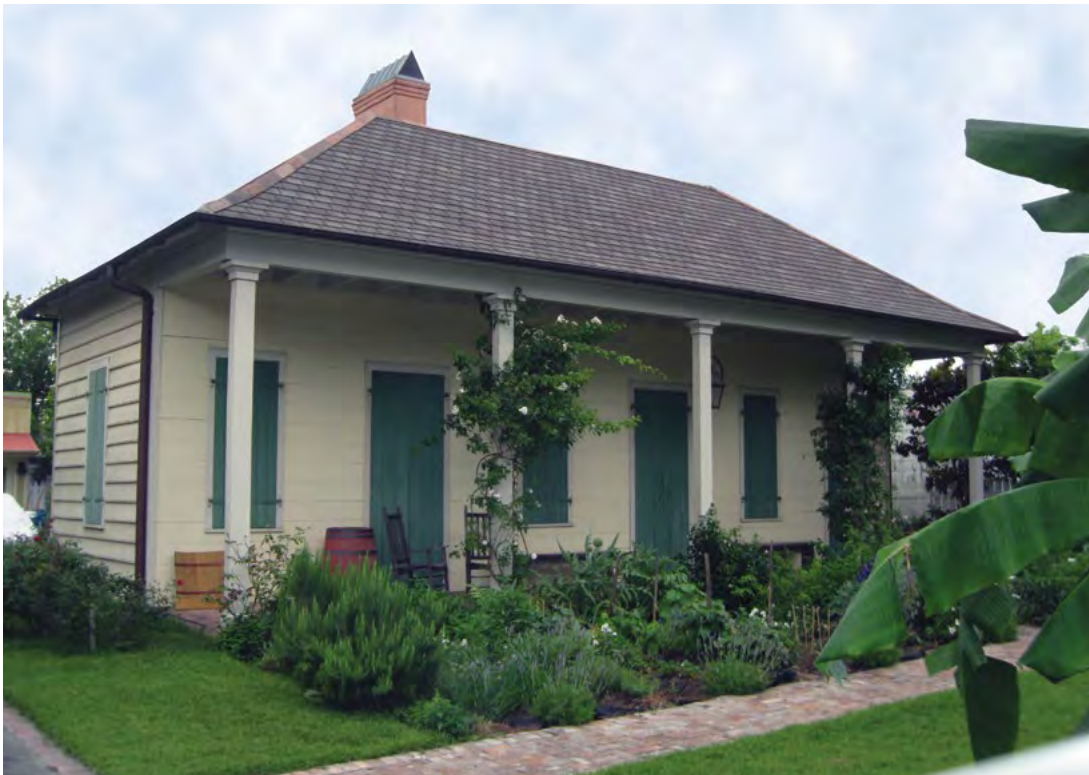
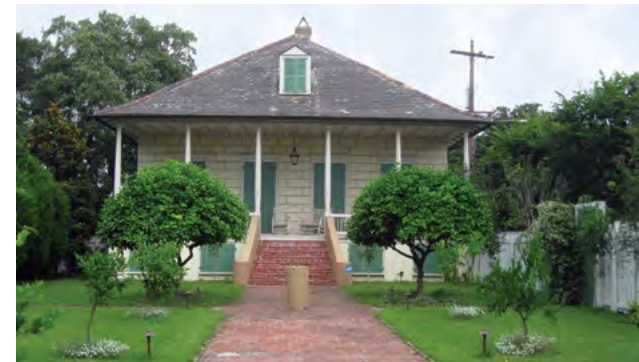
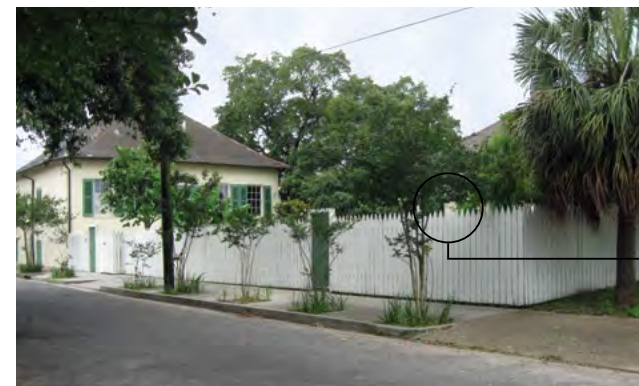
[65] (a) This (far left) is a compatible new outbuilding constructed on the site of a historic plantation house (b). Although traditional in design, it is built of wood to differentiate it from the historic house (which is scored stucco) located at the back of the site so as not to impact the historic house, and minimally visible from the public right-of-way (c).

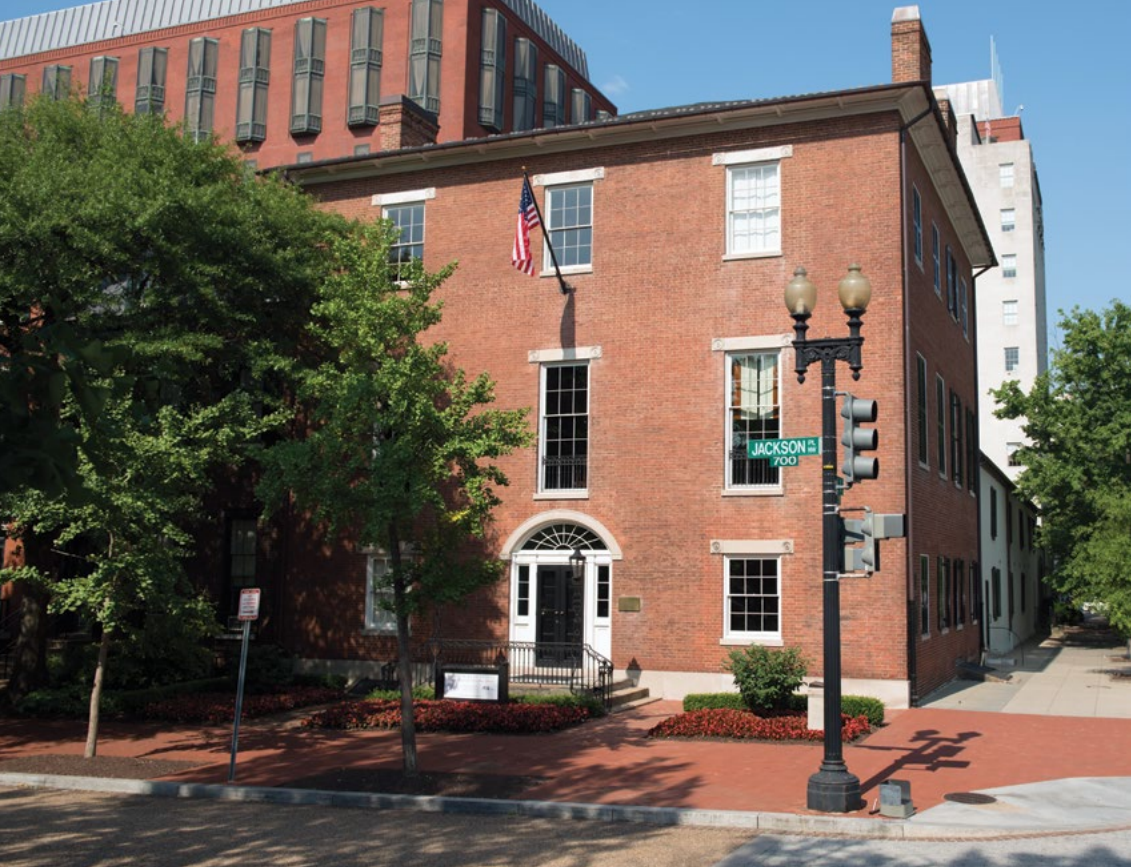
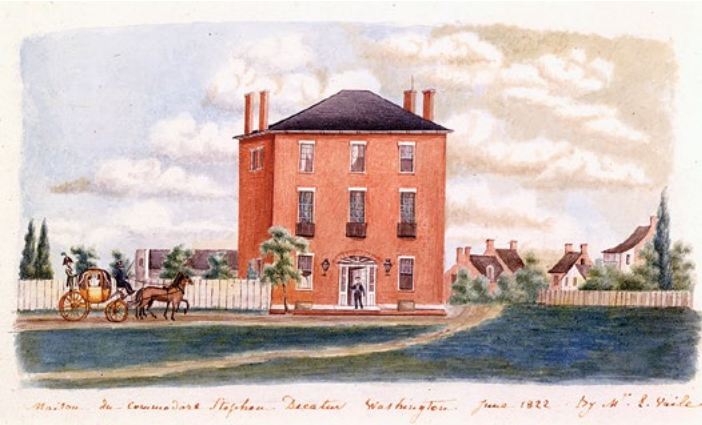
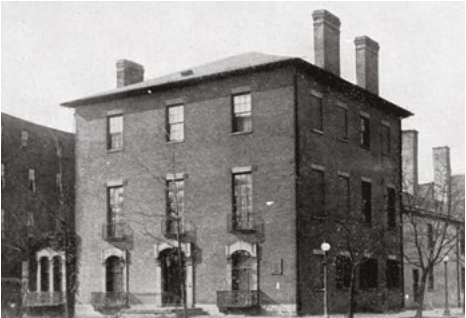
[2] (a) Decatur House in Washington, DC, was designed by William Henry Latrobe and constructed in 1816. (b) In the late-19th century, the façade was “modernized” by removing the limestone lintels on the first floor and replacing them with decorative sandstone lintels in the style of the period. (c) In the mid-20th century, the house was brought back to its original appearance based on historic documentation. Photos: The White House Historical Association and Decatur House, a National Trust Site.

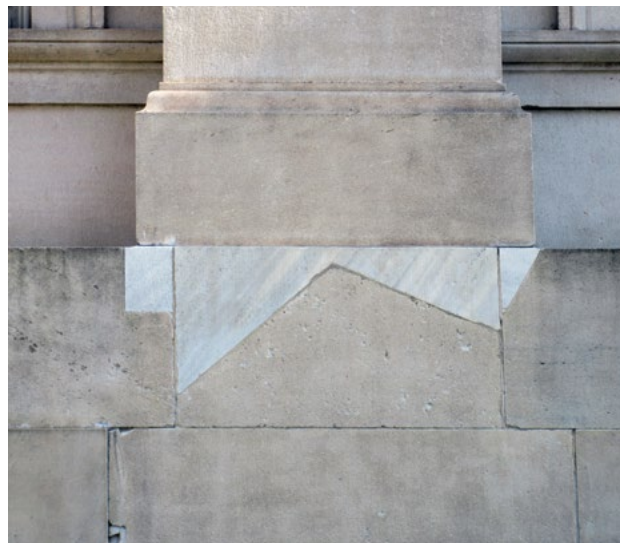
[3] **Not Recommended:** Although the Dutchman stone repair has been well executed, the replacement stone is not a good color match.

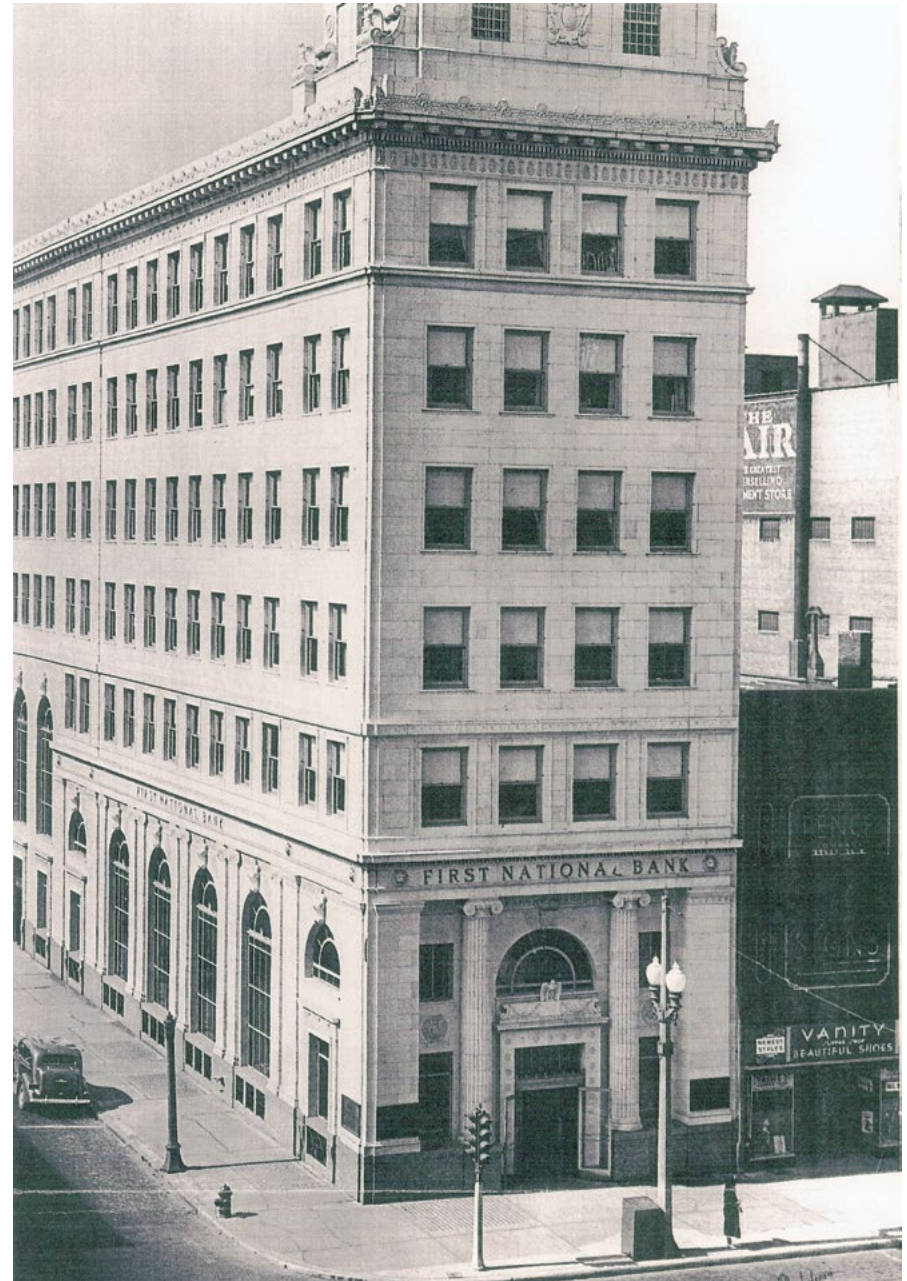
[4] (a) Over the years terra-cotta cladding had been replaced on the lower floors of this early-20th century bank building with a storefront and incompatible windows. (b) A 1936 photograph of the building provided the documentation to restore its historic appearance. (c) Glass fiber reinforced plastic (GFRP) was chosen as a substitute material, and samples were made in a variety of colors and textures to obtain the best match for the missing and damaged terra cotta. (d) This photo taken after restoration shows that the GFRP replacements successfully blend in with the original terra cotta. Photo (d): Blamonet at English Wikipedia.

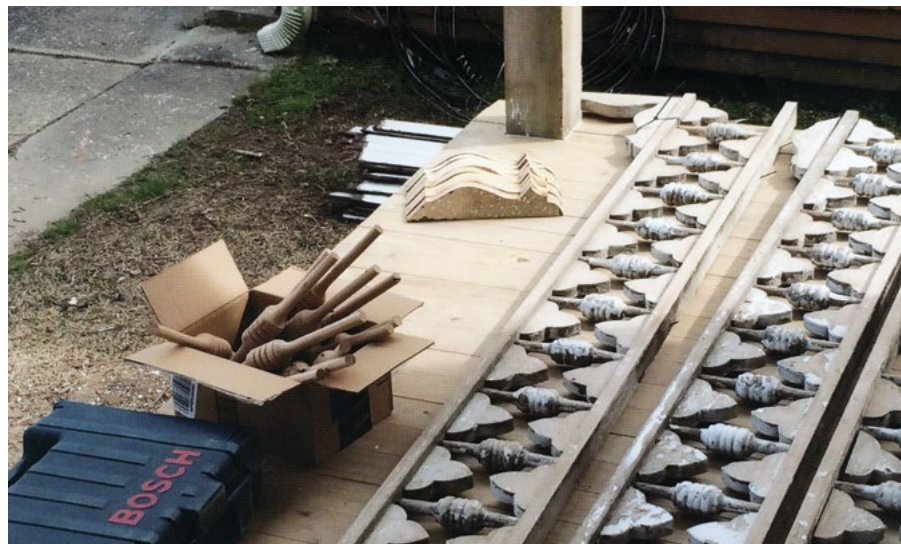
[5] New wood trim pieces were milled to match the few remaining historic features to replace those that were missing.

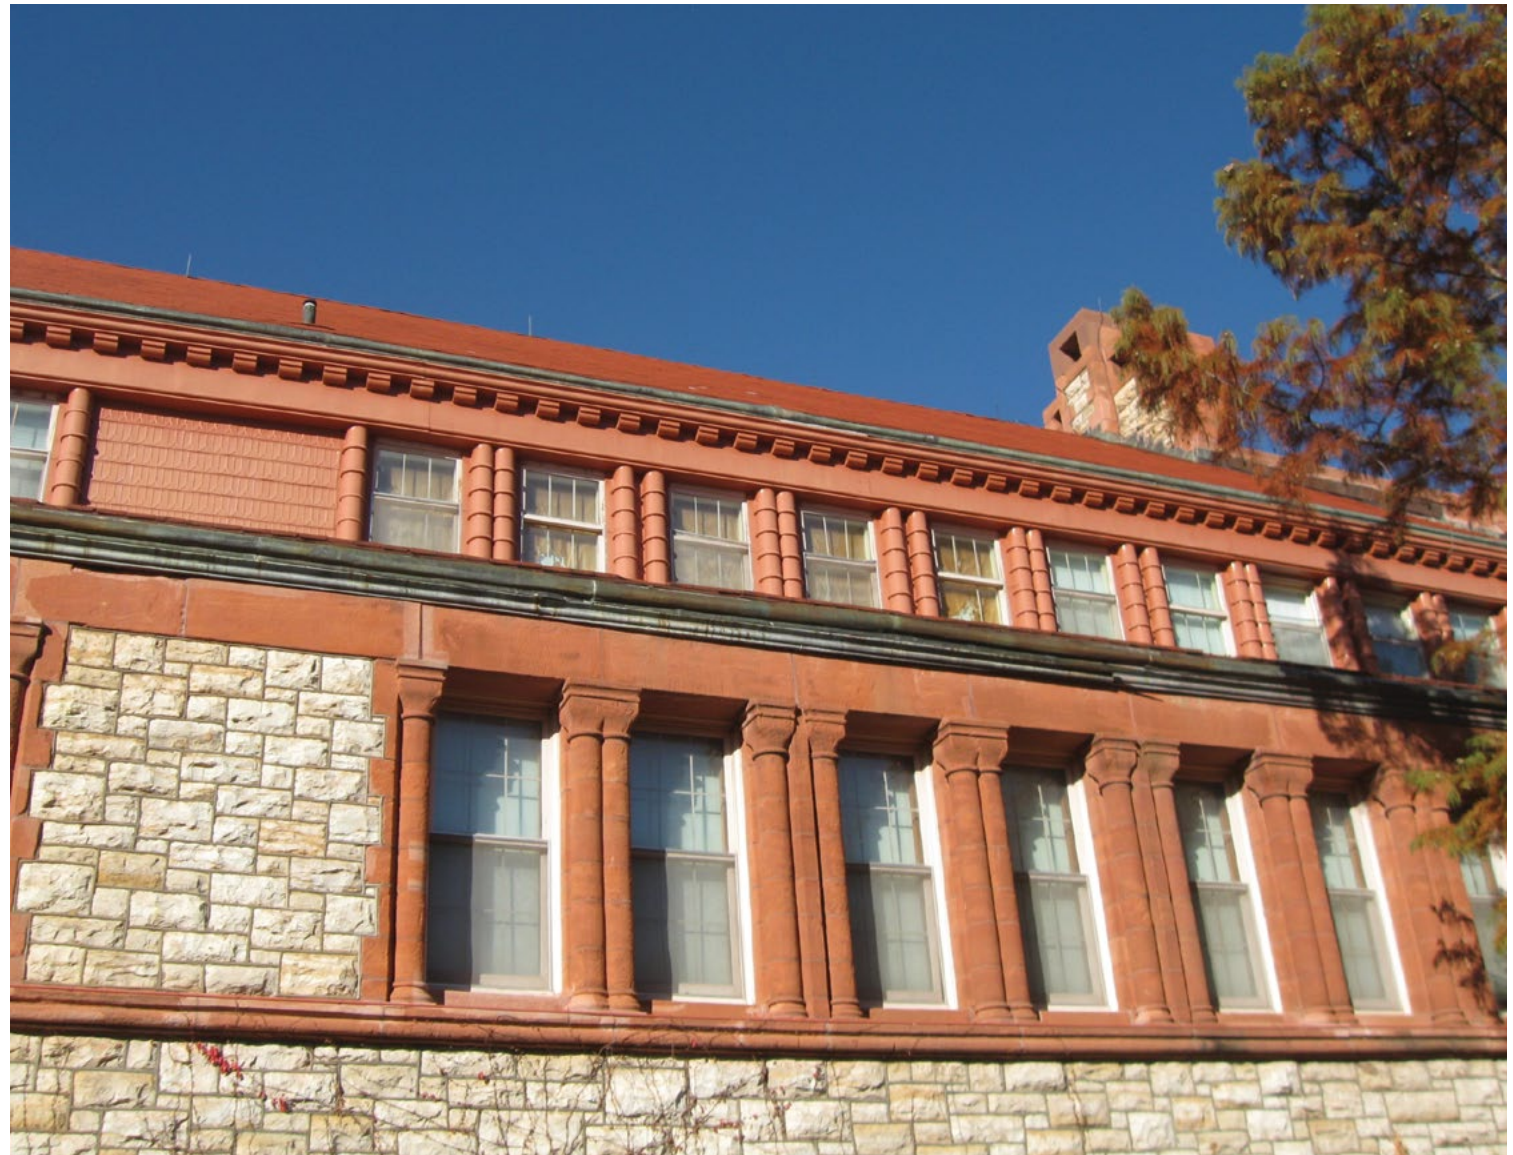
[6] Preliminary work before starting restoration revealed that the columns and the decorative shingles ornamenting the top floor of this historic building were fabricated of metal to imitate the red sandstone used elsewhere on the building.

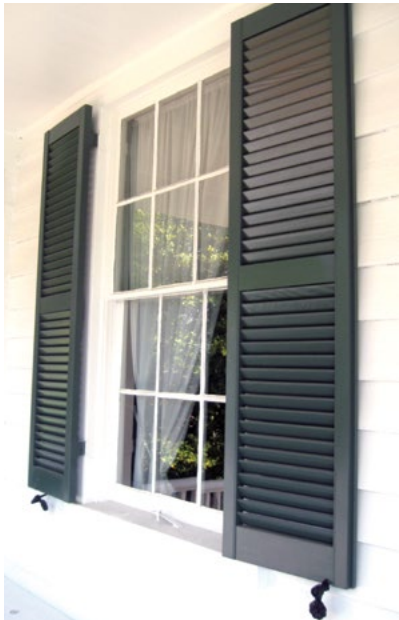
[9] Historic window and shutter hardware such as that shown here should be retained and repaired in a restoration project.

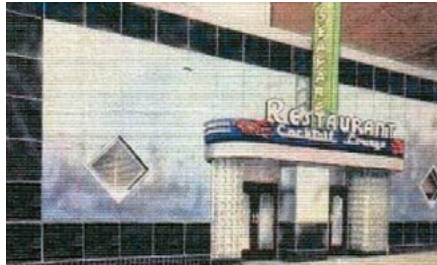
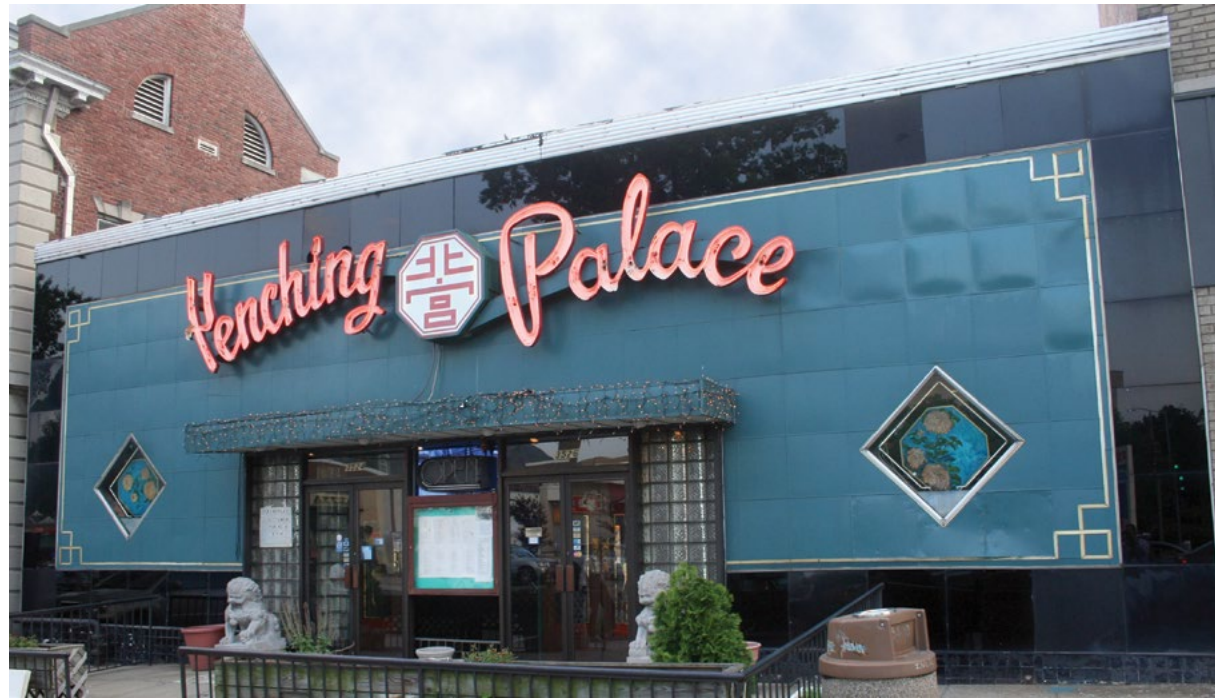
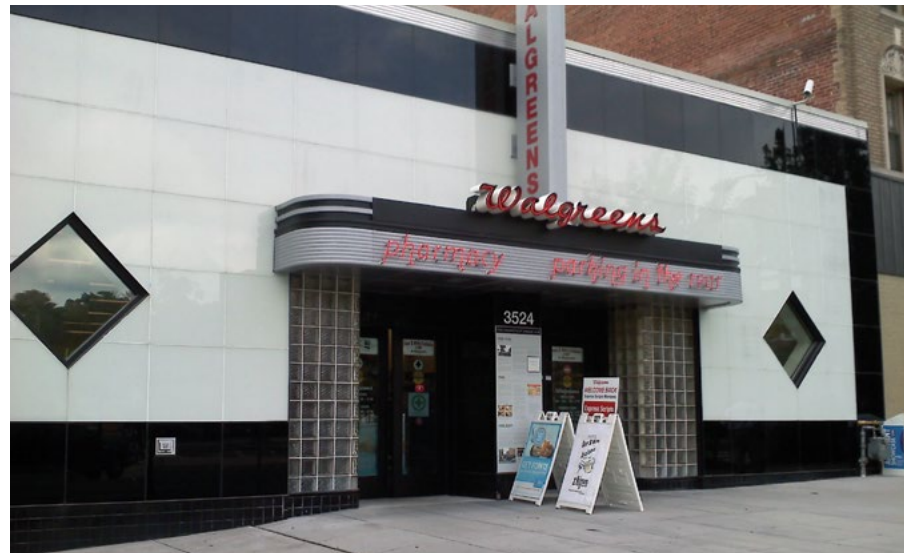
[11] (a) Some of the materials on the front of this historic building had been previously replaced, but the façade retained its essential distinctive features and design. (b) A vintage postcard of the building (far left) provided sufficient documentation to restore the façade to its historic 1945 appearance, using spandrel glass as a replacement for the original Carrara glass (c). Photo (b): Courtesy Kelsey & Associates.

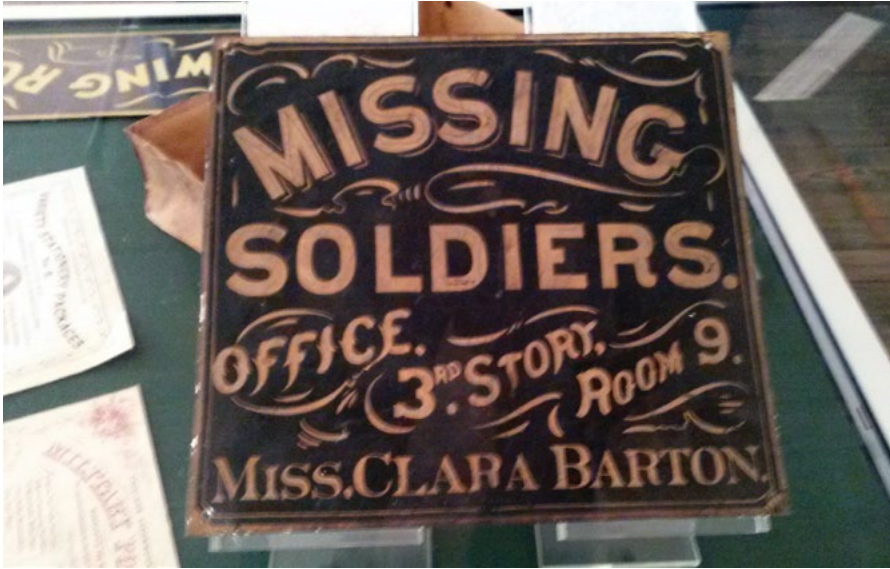
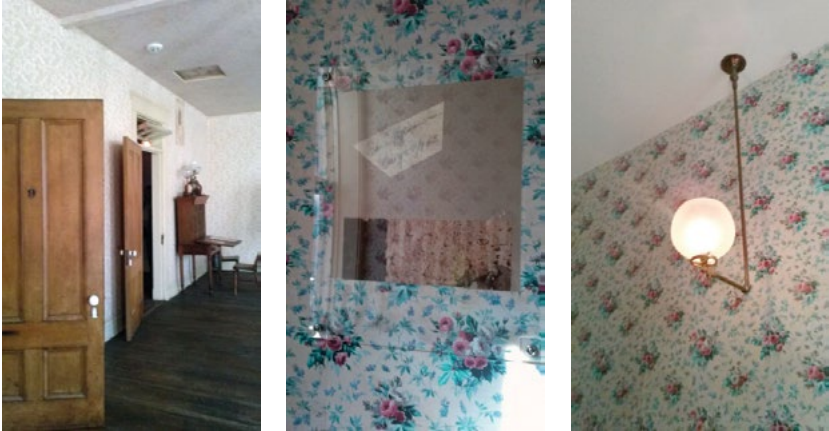
[13] (a) In the 1990s the Missing Soldier's Office—established by Clara Barton at the end of the Civil War—was discovered still extant on the third floor of a building in Washington, DC, that was slated for demolition. The office was restored to its historic appearance using physical and documentary evidence. The original numeral '9' is still on the door to the office, and wall paper was reproduced from scraps found on the walls (b-d).

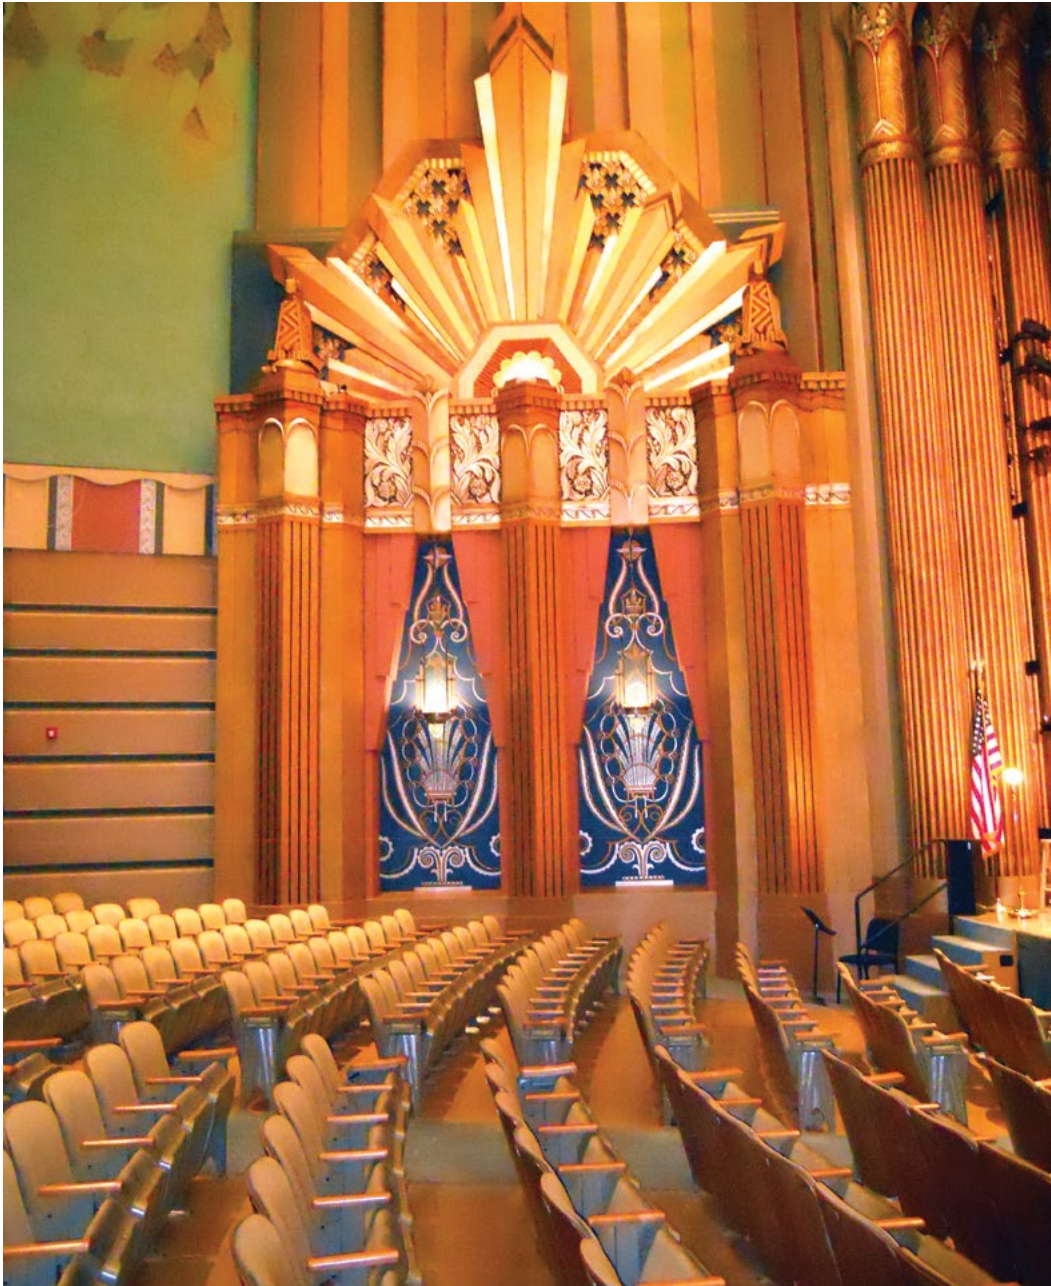
[14] When the 1931 Fox Theater in Spokane, WA, was rehabilitated as a performing arts center, the auditorium was restored to its original Art Deco splendor.

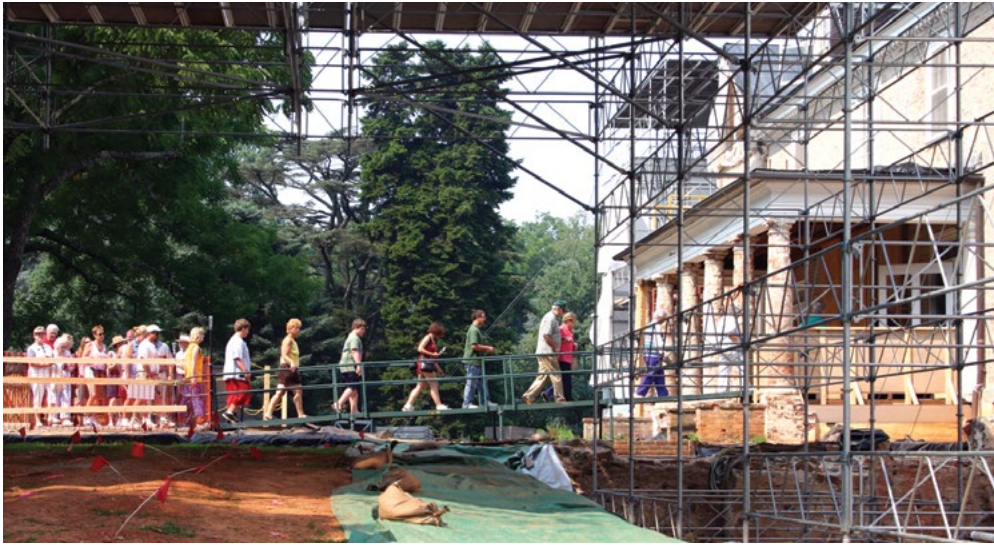
[16] Archeological investigation of the property was undertaken to ensure accuracy of the restoration of Montpelier. Photo: Courtesy of The Montpelier Foundation.

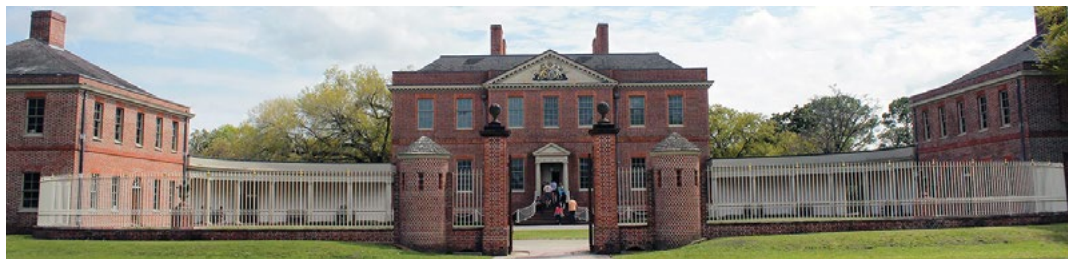
[1 a-b] Tyron Palace, New Bern, NC, was designed by John Hawks in 1767 for Governor William Tyron. It was completed in 1770, but destroyed by fire in 1798. The palace was reconstructed in 1959 based on the original plans, and on its original foundation, which was found 5 feet below the street, with the help of the 1767 drawing. *Photo: Courtesy Tyron Palace, New Bern, NC. Drawing: Courtesy of the State Archives of North Carolina.*
