**Historic Preservation Commission (HPC) Agenda
Tuesday March 21, 2023 5:30 PM
Minturn Town Hall / 302 Pine St Minturn, CO**

The purpose of *The Secretary of the Interior's Standards for the Treatment of Historic Properties and Guidelines for Preserving, Rehabilitating, Restoring and Reconstructing Historic Buildings* is to provide guidance to historic building owners and building managers, preservation consultants, architects, contractors, and project reviewers prior to beginning work. It is always recommended that preservation professionals be consulted early in any project.

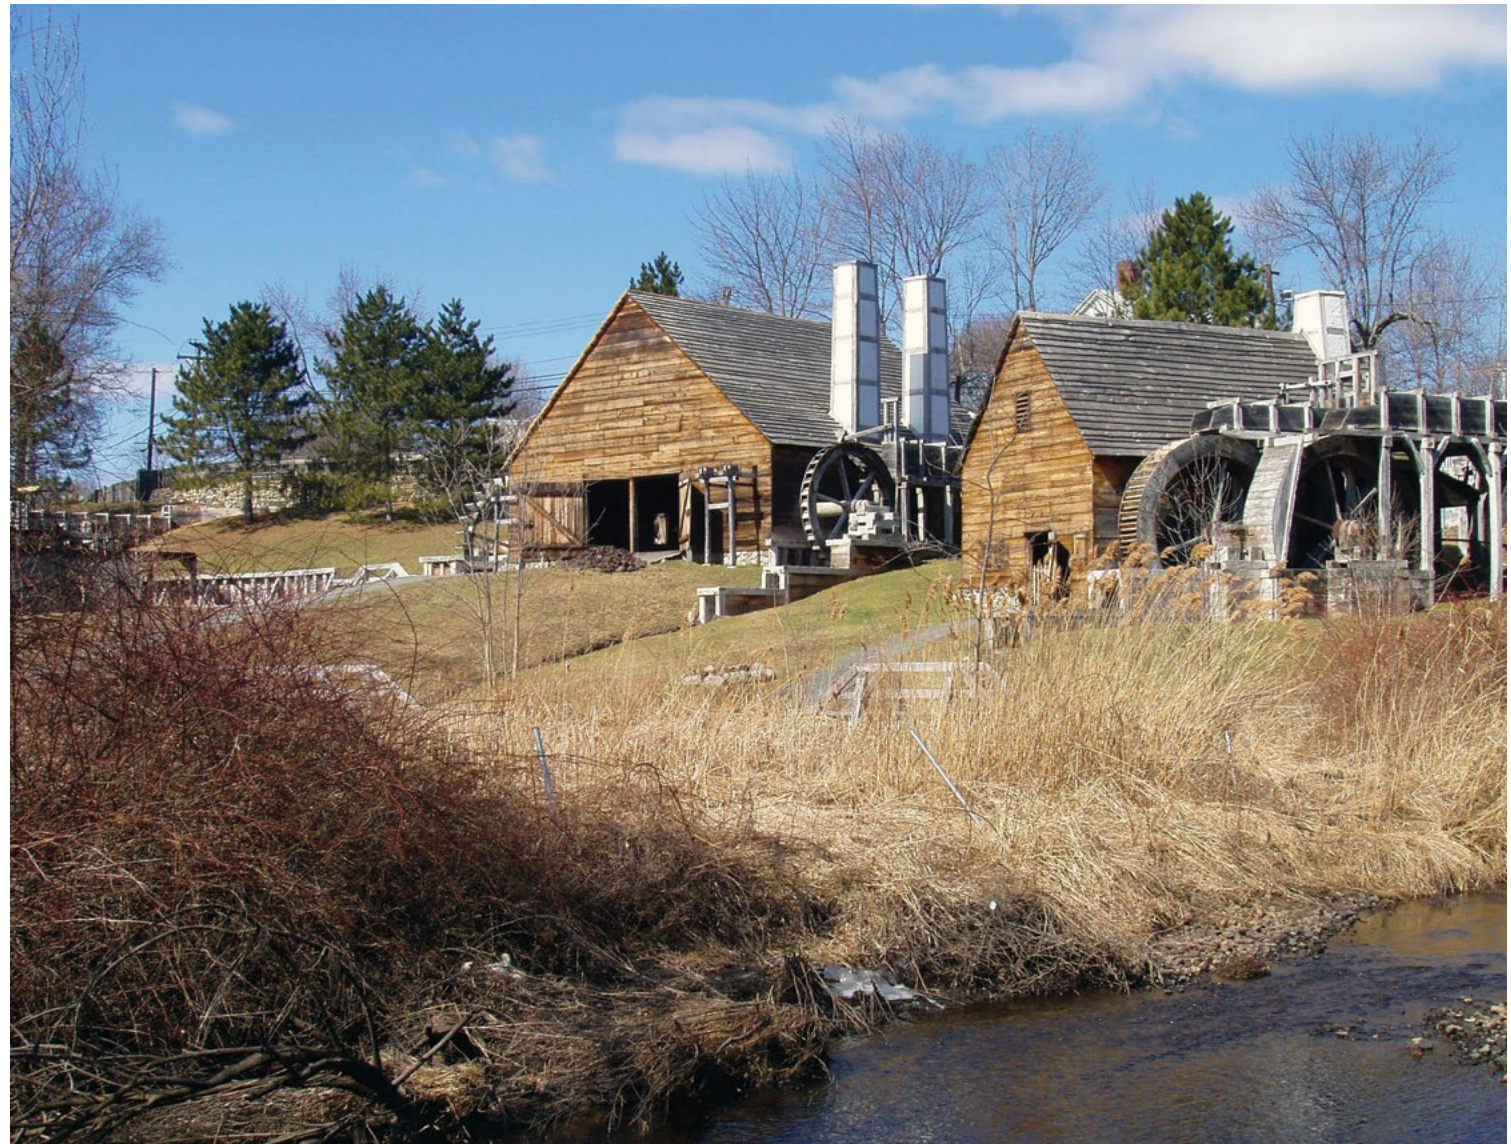
[2] The Saugus Iron Works, Saugus, MA, a National Historic Site, was active from 1646 to about 1670 and was the first integrated iron works in North America. The forge and mill (shown here) are part of the site which was reconstructed based on archeological research and historic documents and opened in 1954. *Photo: Daderot at the English language Wikipedia.*

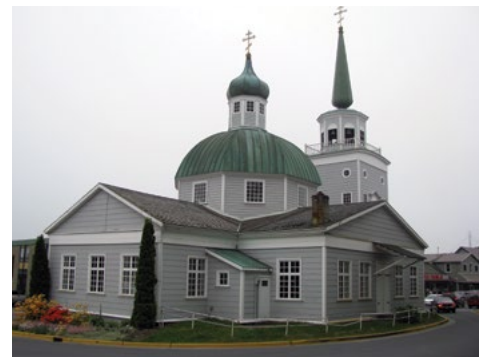
[3] The Cathedral of Saint Michael the Archangel, built in the early 1840s in Sitka, AK, was devastated by fire in 1966. It was reconstructed using measured drawings done in 1961 by the Historic American Buildings Survey (HABS). While the original cathedral was built of logs covered on the exterior with wood siding, its replacement is a fire-resistant structure with concrete and steel walls that replicates the historic building's appearance. *Photo: Berek at Wikimedia Commons.*

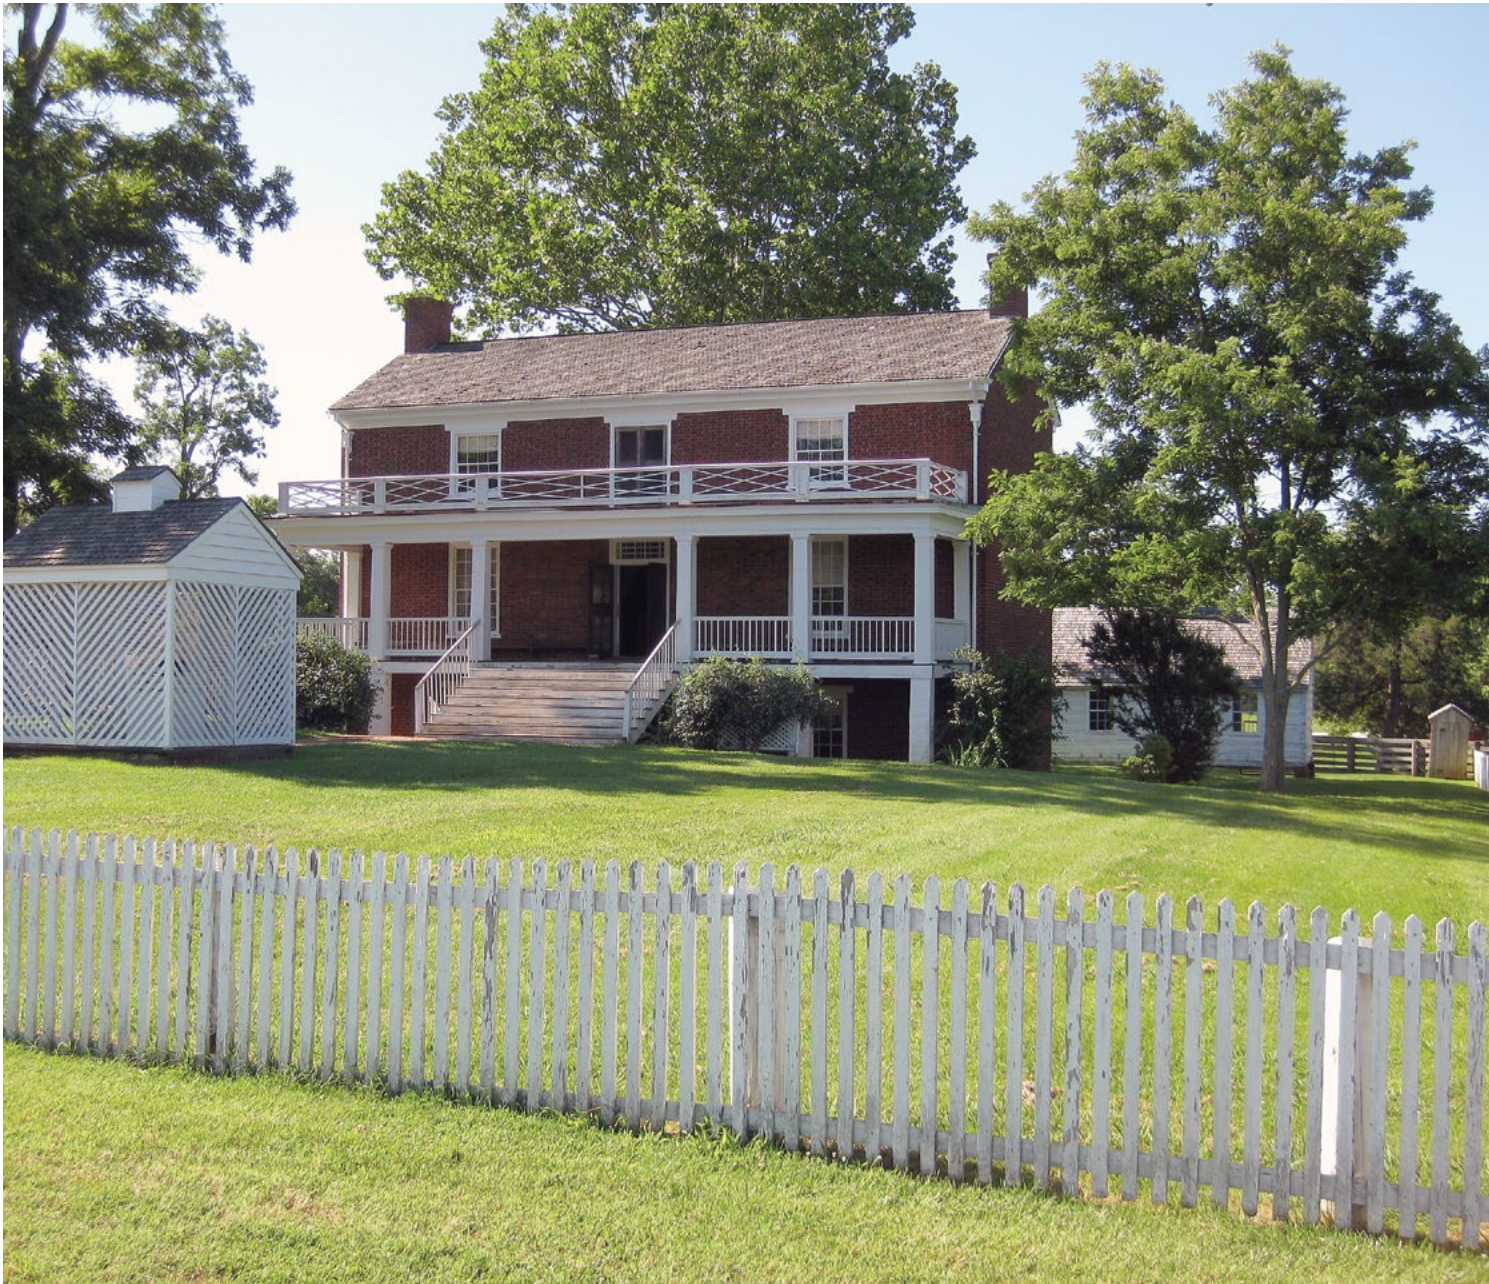
[4] The McLean House, where Robert E. Lee surrendered to Ulysses S. Grant, is located on the site of the battlefield—now part of Appomattox Courthouse National Historical Monument (VA). Several years after the end of the Civil War, measured drawings were made of the house before it was dismantled to be moved to Washington, DC, where it was to be reconstructed as a tourist attraction. This scheme never came to fruition, and the dismantled pieces gradually disappeared. The house was accurately reconstructed in 1949 on the original site based on the measured drawings.

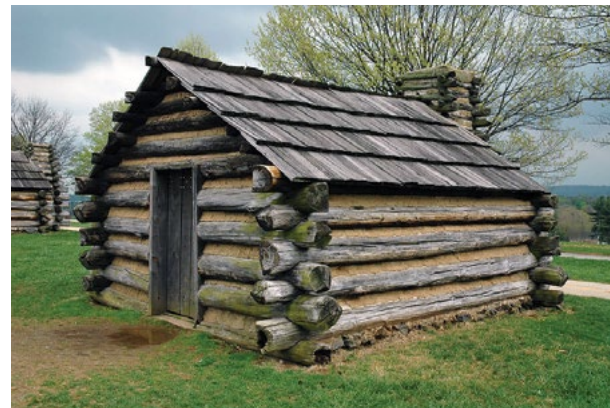
[7] The Muhlenberg Brigade Huts are reconstructions of nine log huts erected in 1777 at Valley Forge during the Revolutionary War. They have been reconstructed on the historic road with logs cut with modern power tools and finished with cement, unlike the original logs which were hand hewn and finished with traditional chinking. *Photo: Rdsmith4 at Wikimedia Commons.*

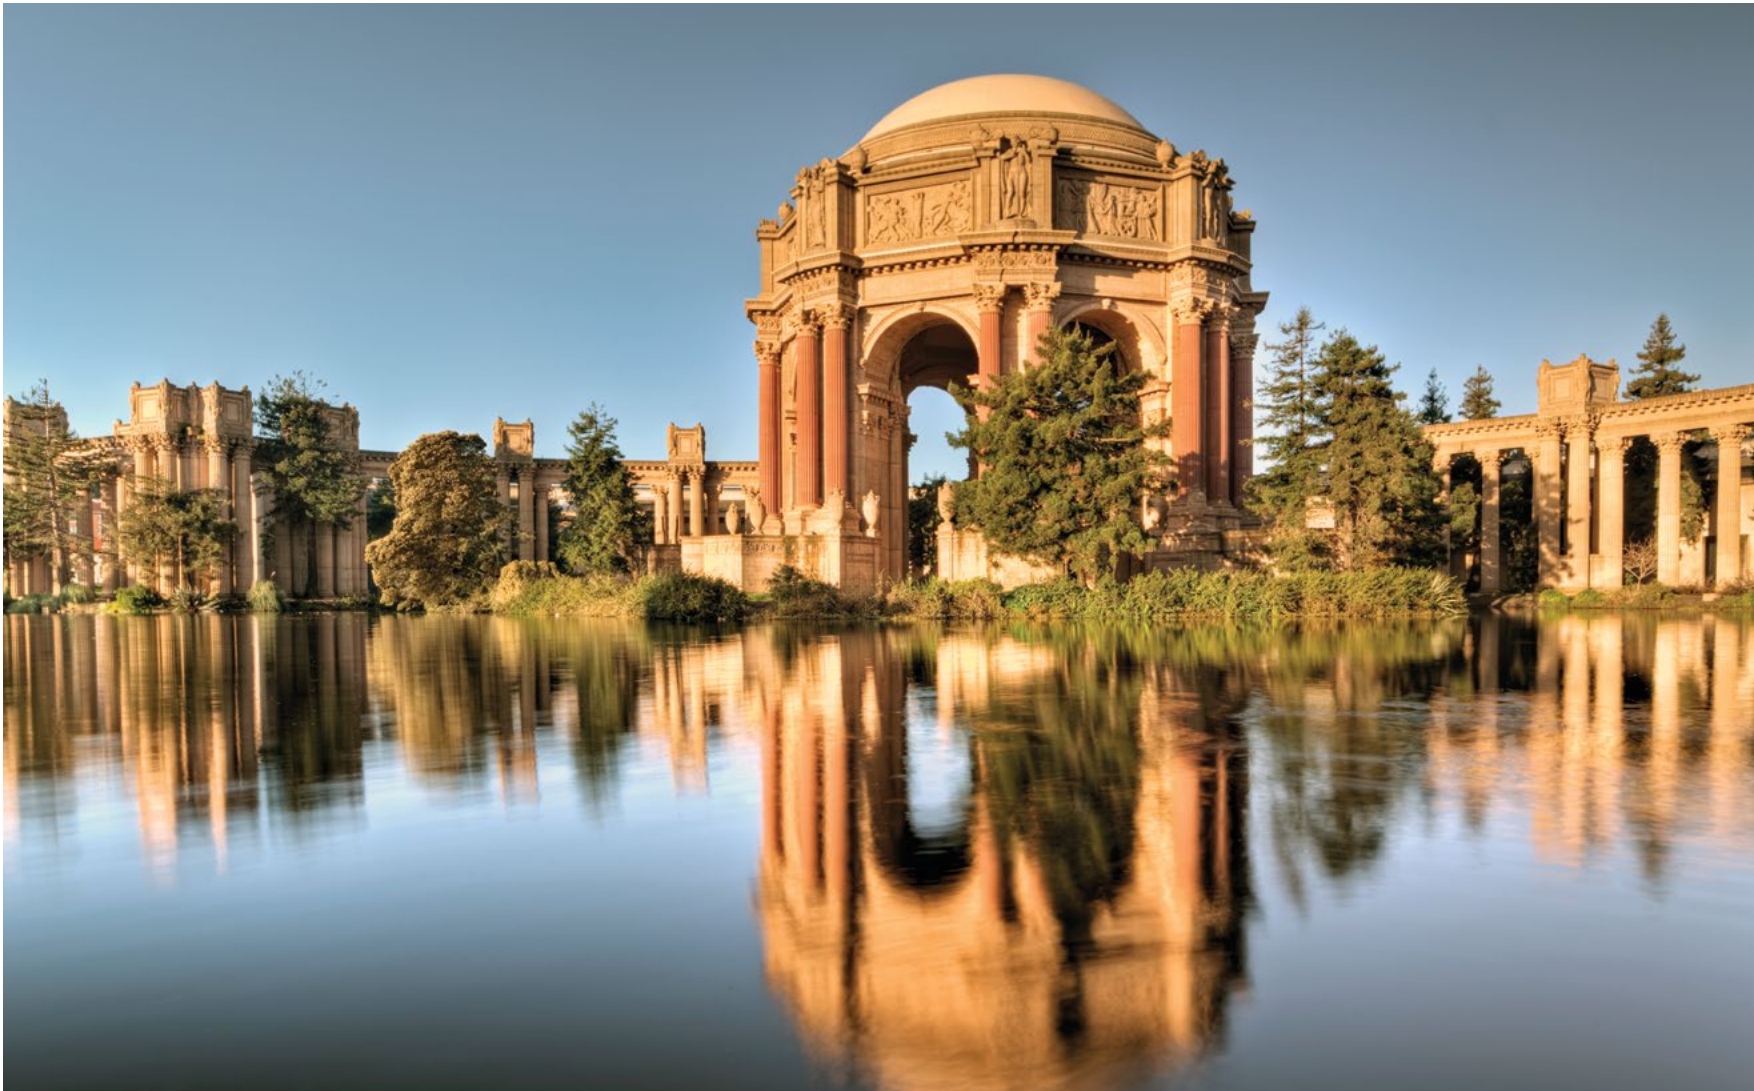
[8] The Palace of Fine Arts was designed by Bernard Maybeck and built for the 1915 Panama-Pacific Exposition in San Francisco. The pavilion was intended to be temporary and, although it had a steel structure, the exterior was finished only with stucco, an impermanent material composed of plaster and fiber. The building was not torn down after the exposition, and it eventually fell into ruin. In 1964, all but the steel structure was demolished, and the building was reconstructed with lightweight poured-in-place concrete. *Photo: KevinIcole at Wikimedia Commons.*
